Access Report for Charters Towers

Charters Towers QLD 4816

**A report by:
John Mayo
Access Solutions
109 Logan Rd
Woolloongabba 4102
Phone: (07) 3391 2044
Fax: (07) 3391 2088**

Executive Summary

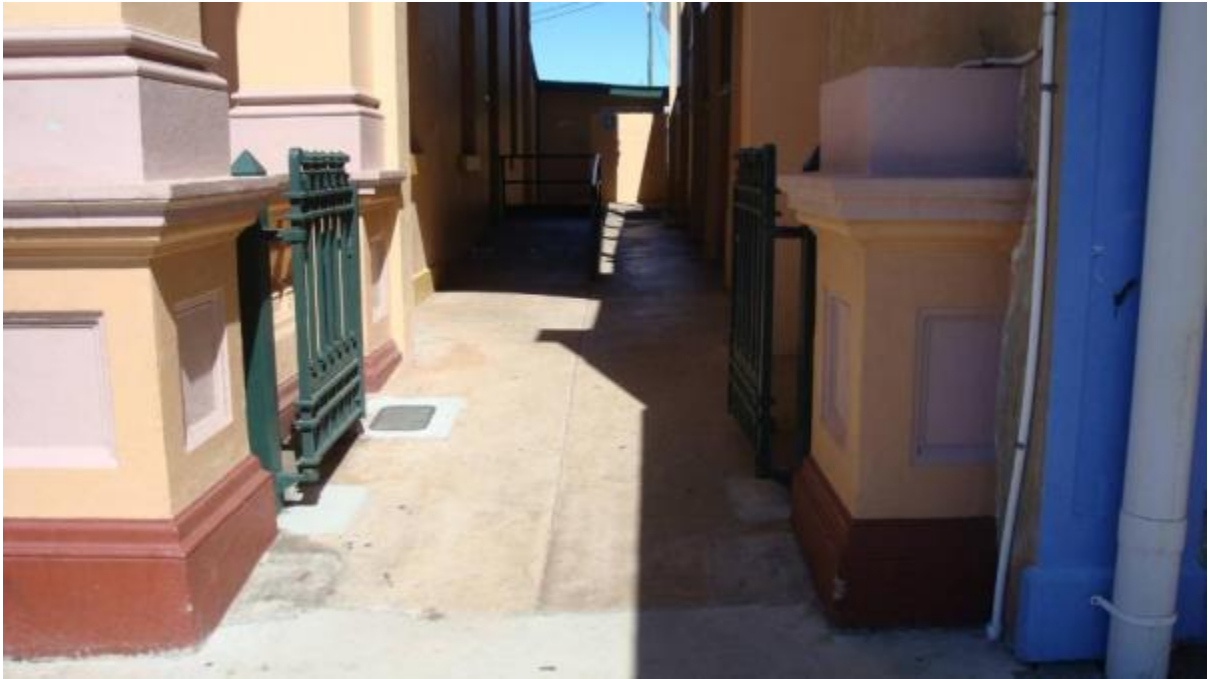
Photo 5

Public toilet adjacent to Century 21 tenancy. Comprising Ladies and 1 x Accessible Uni-sex toilet.

The existing door threshold is ramped. A level threshold at the door is recommended.

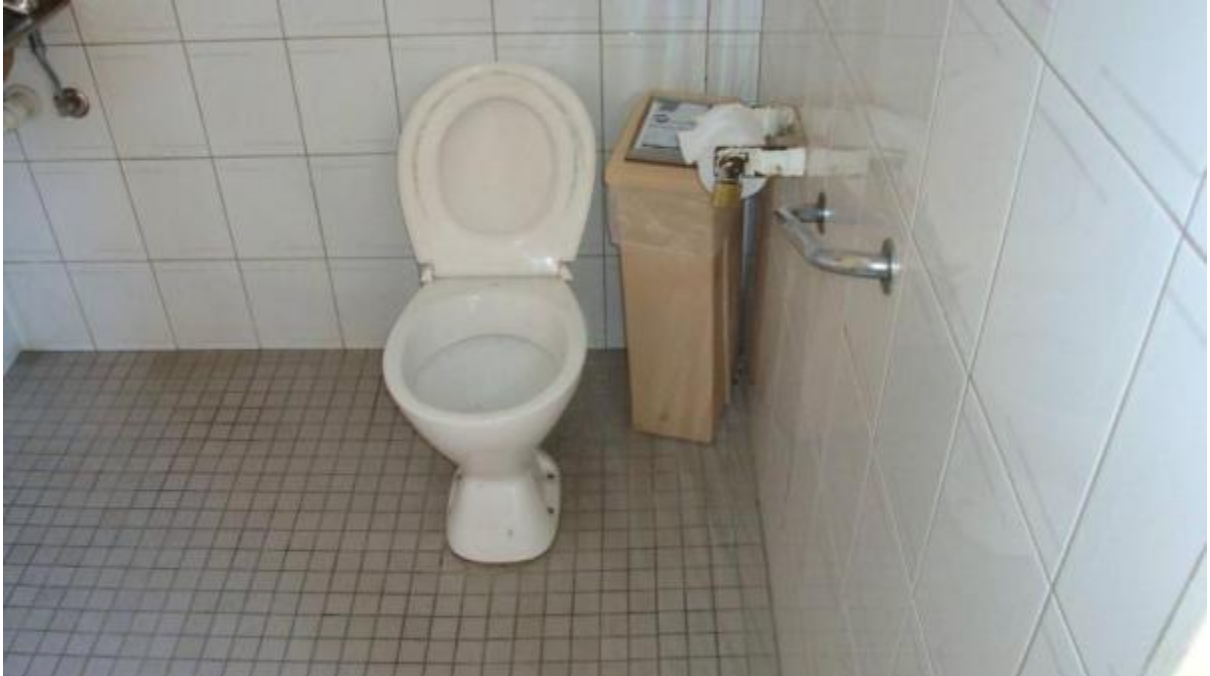
Photo 8

Grab rail is noncompliant as is position of toilet roll holder. Upgrade to comply with AS1428.2 – 1992.

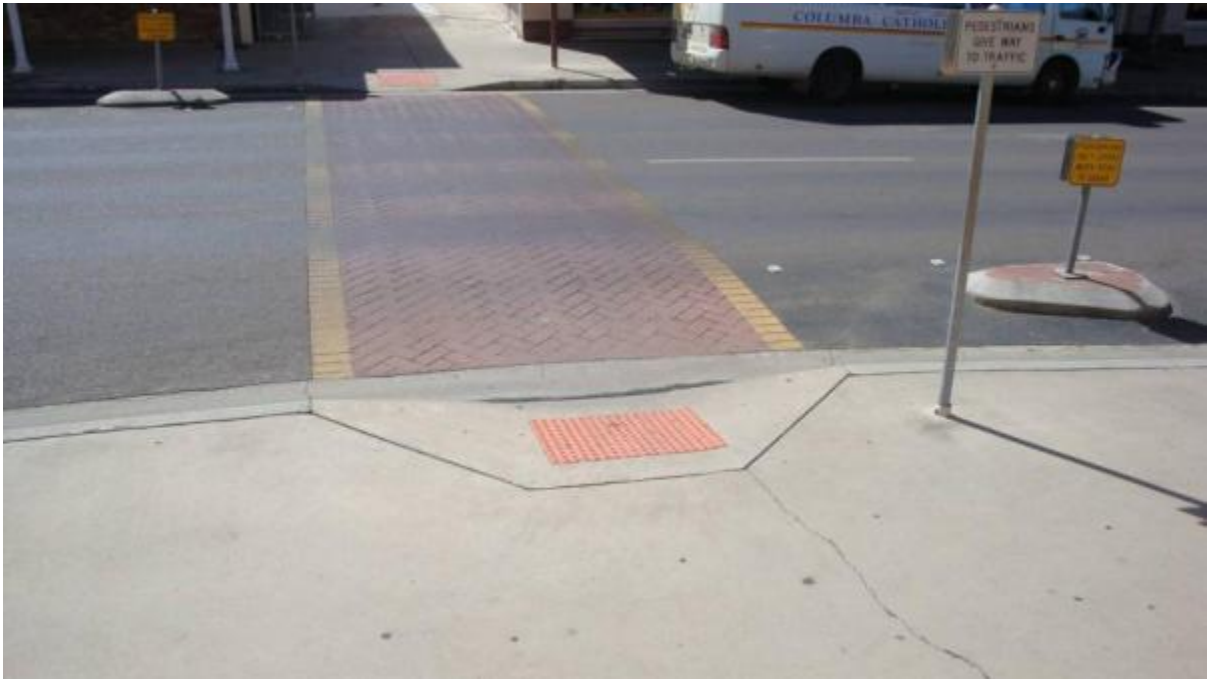
Photo 11

Pedestrian crossing connecting Century 21 tenancy with Westpac bank signed 'Pedestrians give way to traffic.' This is not conventional or acceptable; it is unsafe

Remove Hazard Tactile Ground Surface Indicators from the face of kerb ramps. They must be at the top of the kerb ramp to comply with AS1428.2 - 1992.

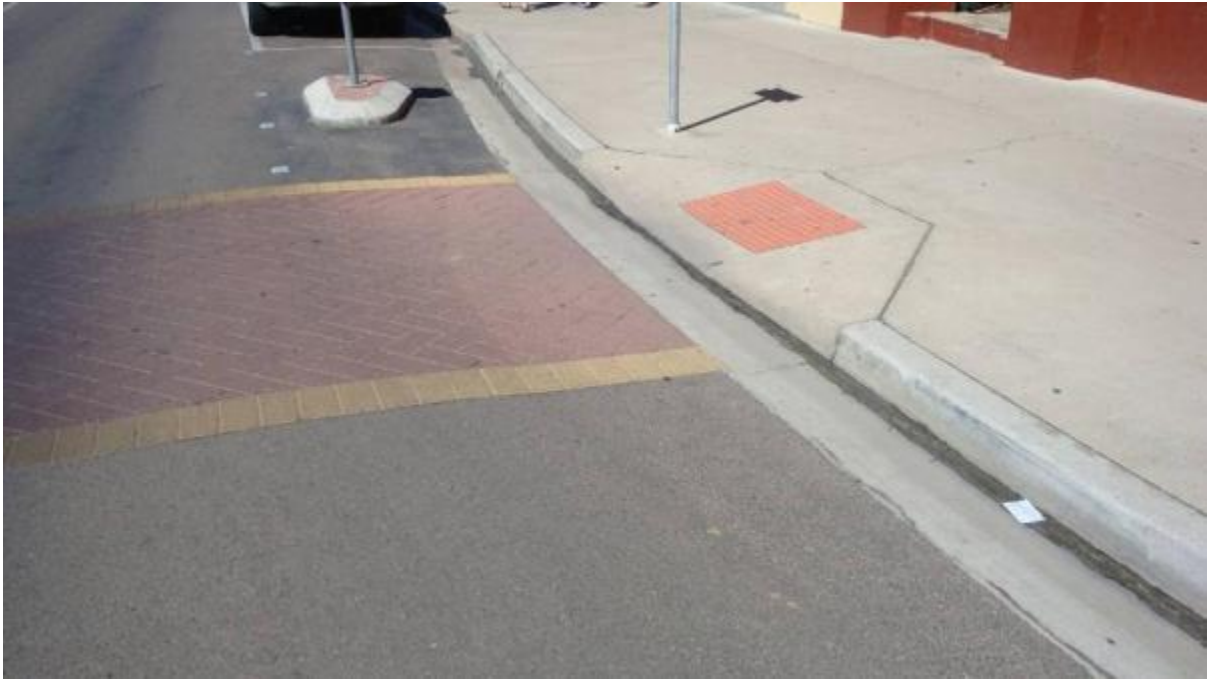
Photo 12

The road crowns into the existing kerb ramps and re-grading should occur. Try to achieve a gradient for the kerb ramp of 1: 9 or gentler.

Remove Hazard Tactile Ground Surface Indicators from the face of kerb ramps. They must be at the top of the kerb ramp to comply with AS1428.2 - 1992.

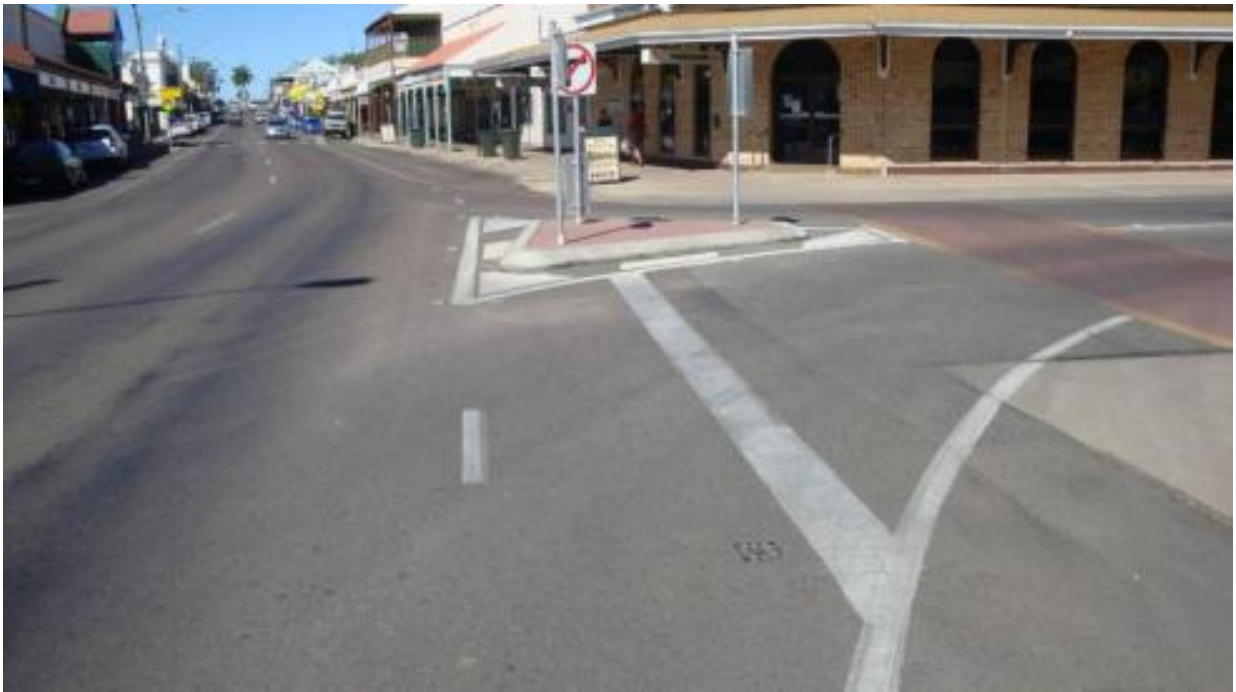
Photo 14

Crossing Deane Street is difficult for mobility device users because there is no designated crossing for pedestrians. Recommendation is to:

- (a) Make the pedestrian crossing a 'zebra' crossing
- (b) Re-line mark the stop 'wide' line marking further forward to align with the existing line marking at the front of the existing stop island, as per photo 14. Add strip of Hazard Tactile Ground Surface Indicators as per AS1428.4 on the footpath.

If driveway between Geoff Byrne lawyers and Health and Harmony tenancies is operative – installation of Hazard Tactile Ground Surface Indicators are required as per AS1428.4

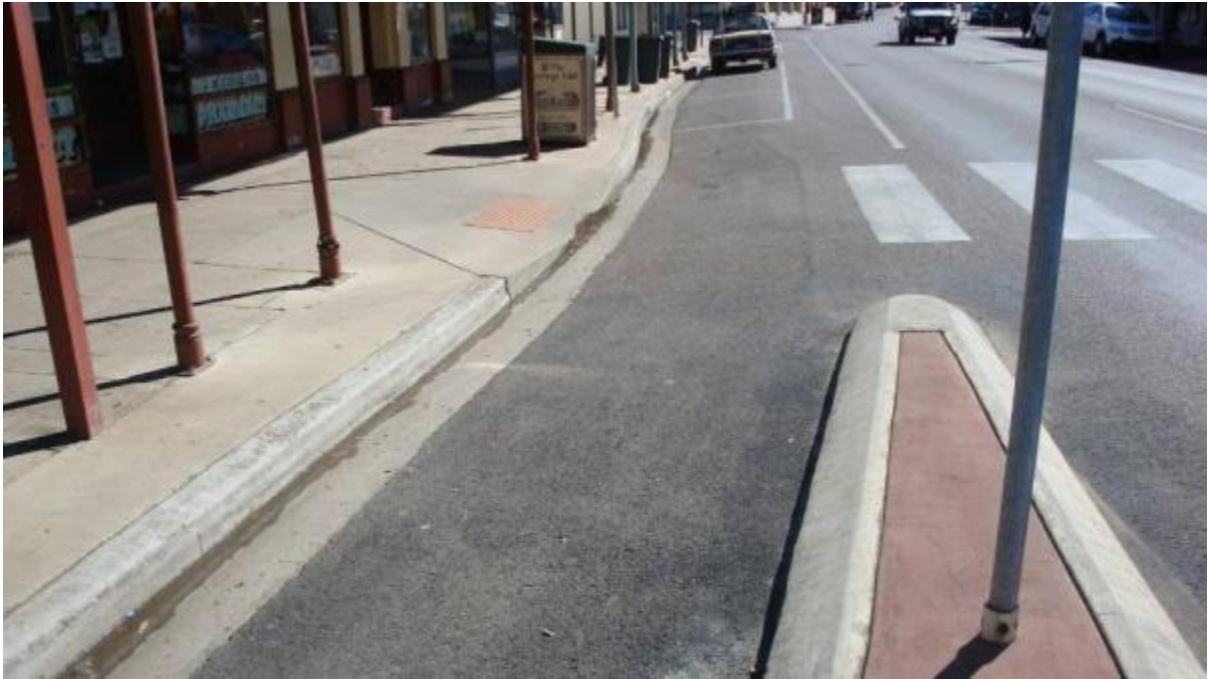
Photo 15

Pedestrian crossing connecting Collins pharmacy with Town Plaza.

Remove Hazard Tactile Ground Surface Indicators from the face of kerb ramps.
They must be at the top of the kerb ramp to comply with AS1428.2 - 1992.

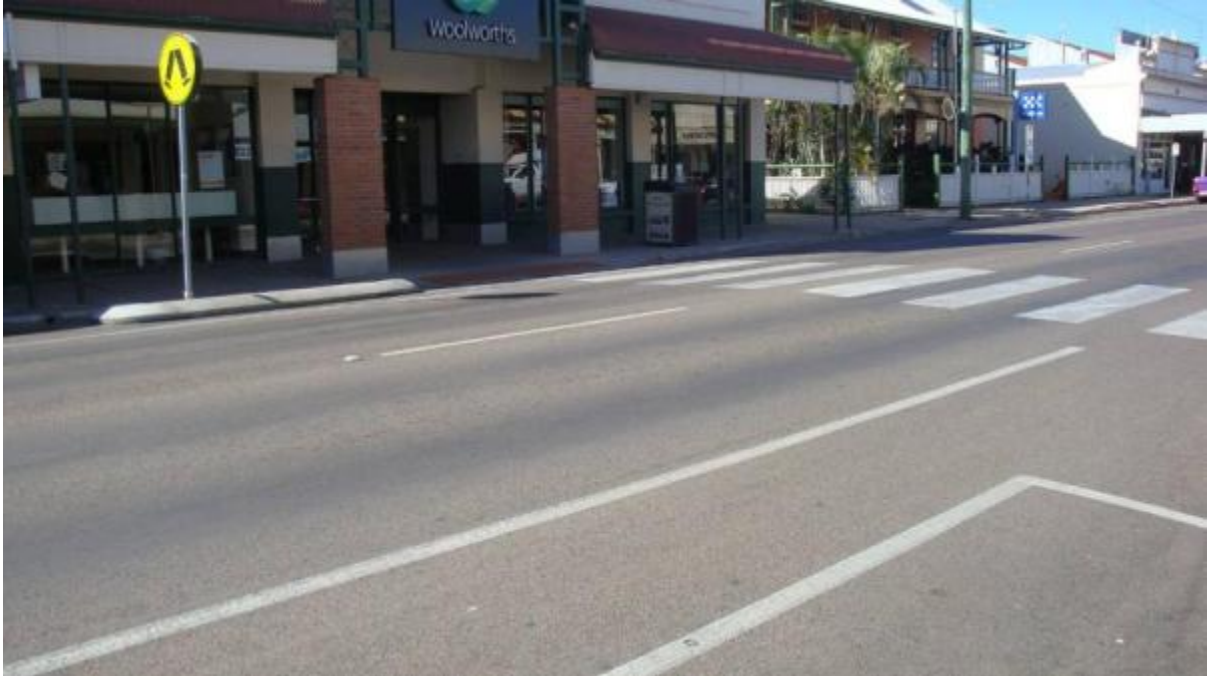
Photo 16

The problem for both sides is the significant crowning of the road and the unsafe wedge shape transition at footpath connections. Engineering should examine if:

Install Hazard Tactile Ground Surface Indicators to comply with AS1428.2 - 1992.

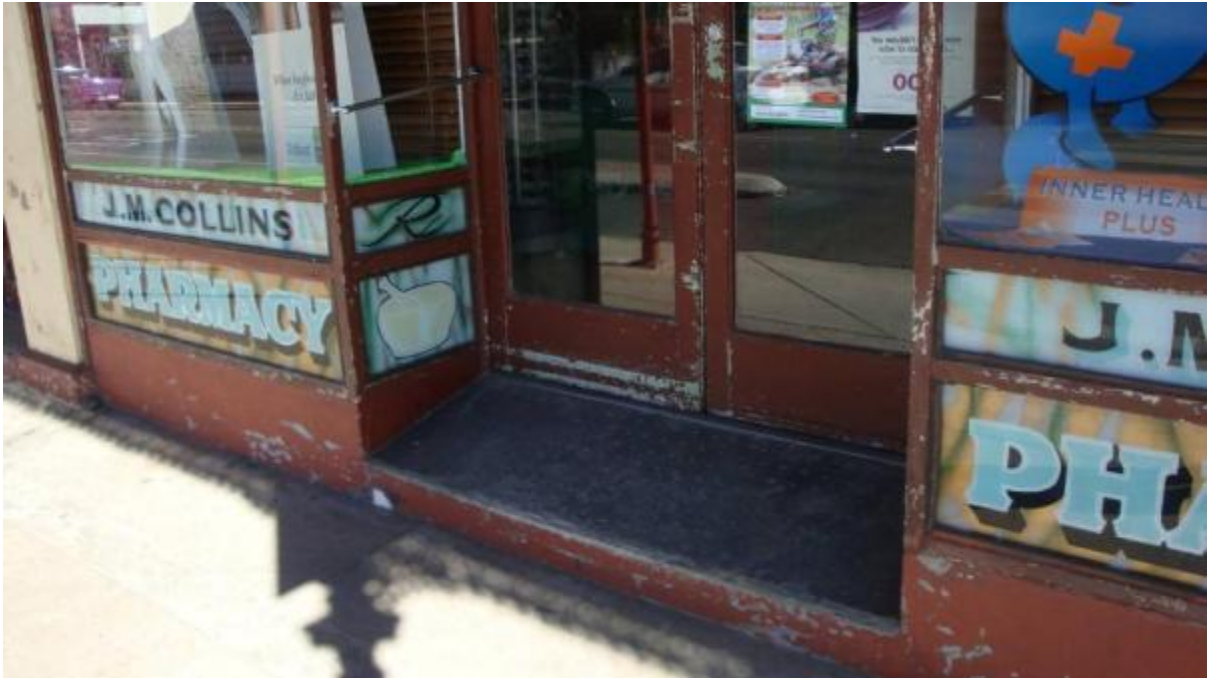
Photo 17

Collins Pharmacy has noted pedestrians need assistance to deal with steps and sloping entries. Tea towel rails have been added to grab onto.

Property owners should be encouraged to offer a compliant solution.

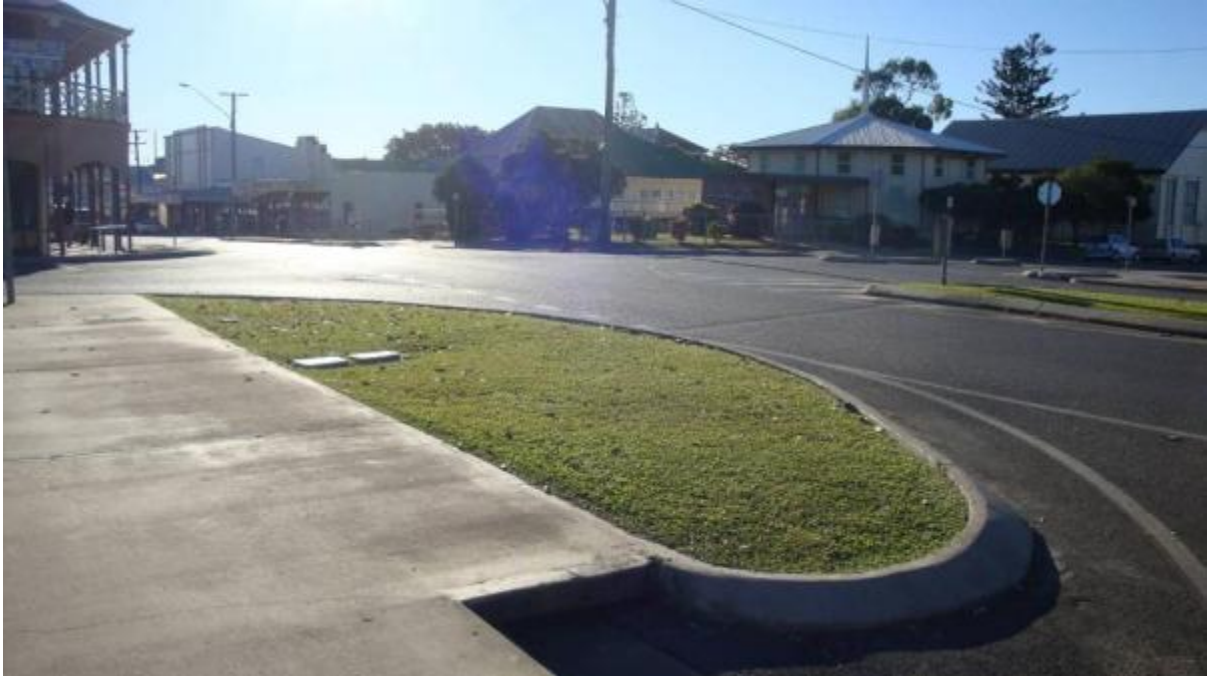
Photo 23

It is noted that the issues would be less complicated if vehicles were not allowed to turn right off Gill Street into Church Street.

Recommend closing the existing crossing down and force use of crossing at McDonalds. The alternative is a signalized controlled pedestrian crossing outside the Library that will halt vehicle traffic.

Turn the pedestrian crossing in Church Street (south and north) into 'zebra' crossings with Hazard Tactile Ground Surface Indicators.

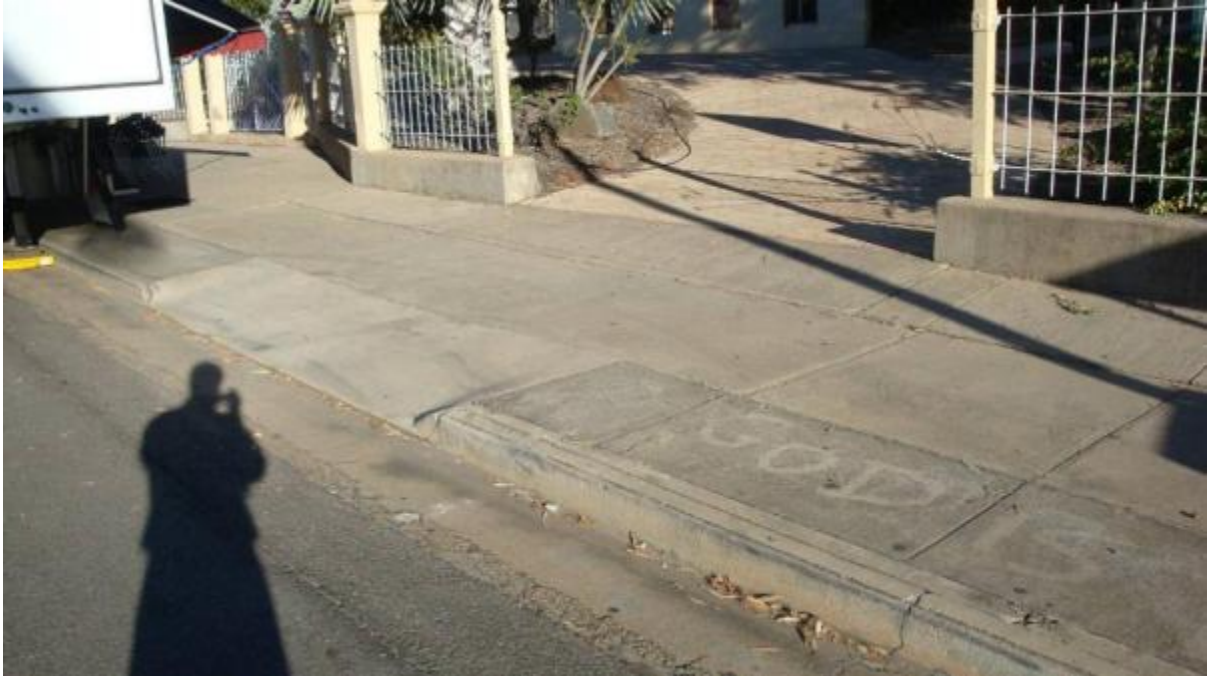
Photo 24

Two driveways at St Columba's Church require Hazard Tactile Ground Surface Indicators as per AS1428.4 each side of each driveway.

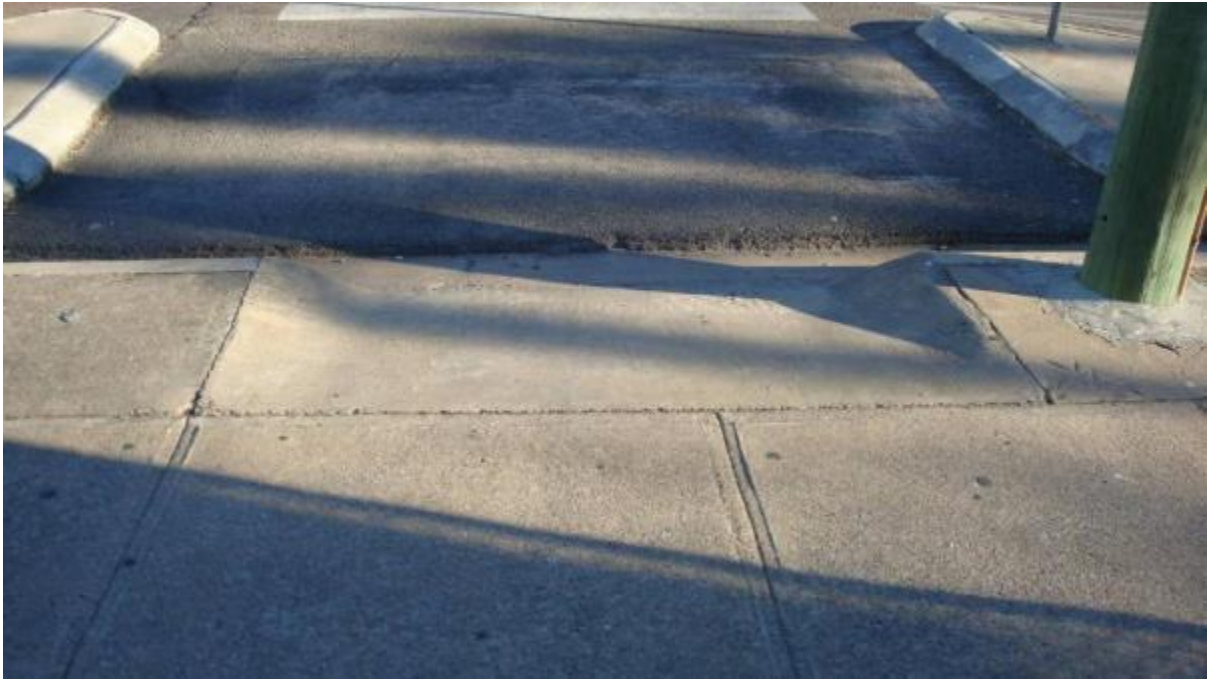
Photo 28

The existing McDonalds kerb ramp is just as bad as its counterpart across the road. A flat wide transition should be easy to achieve. In that case install Hazard Tactile Ground Surface Indicators. AS1428.4

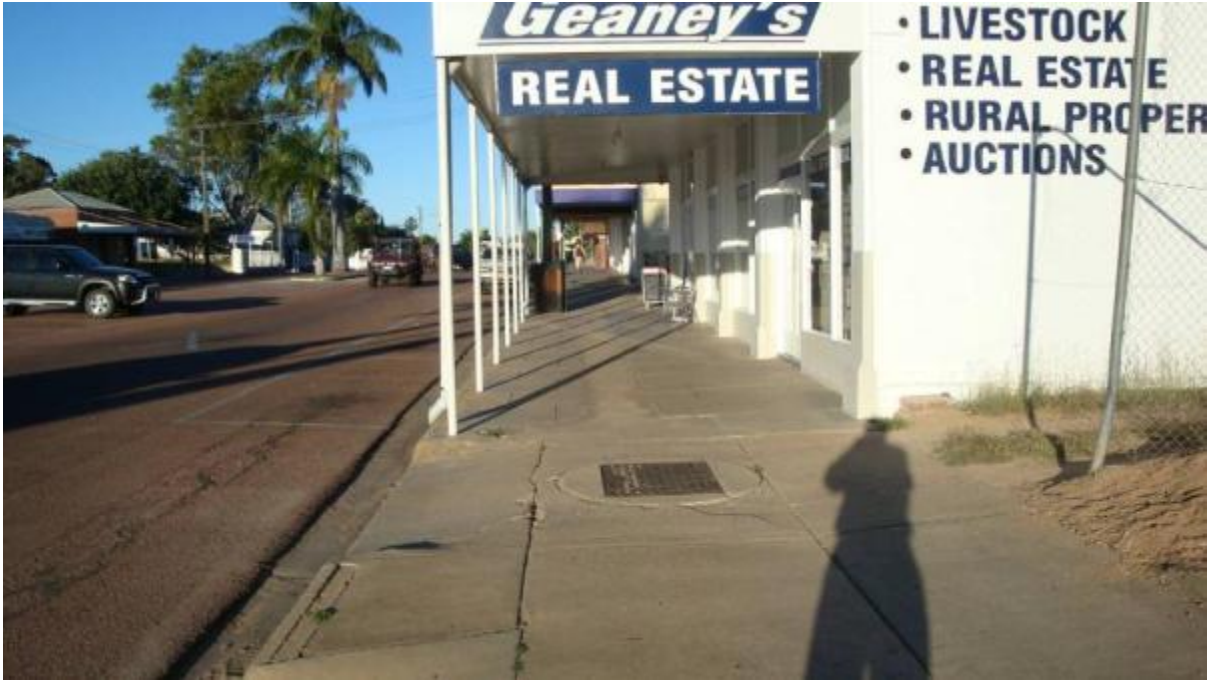
Photo 28a

Driveway at Geaney's Real Estate requires Hazard Tactile Ground Surface Indicators each side as per AS1428.4

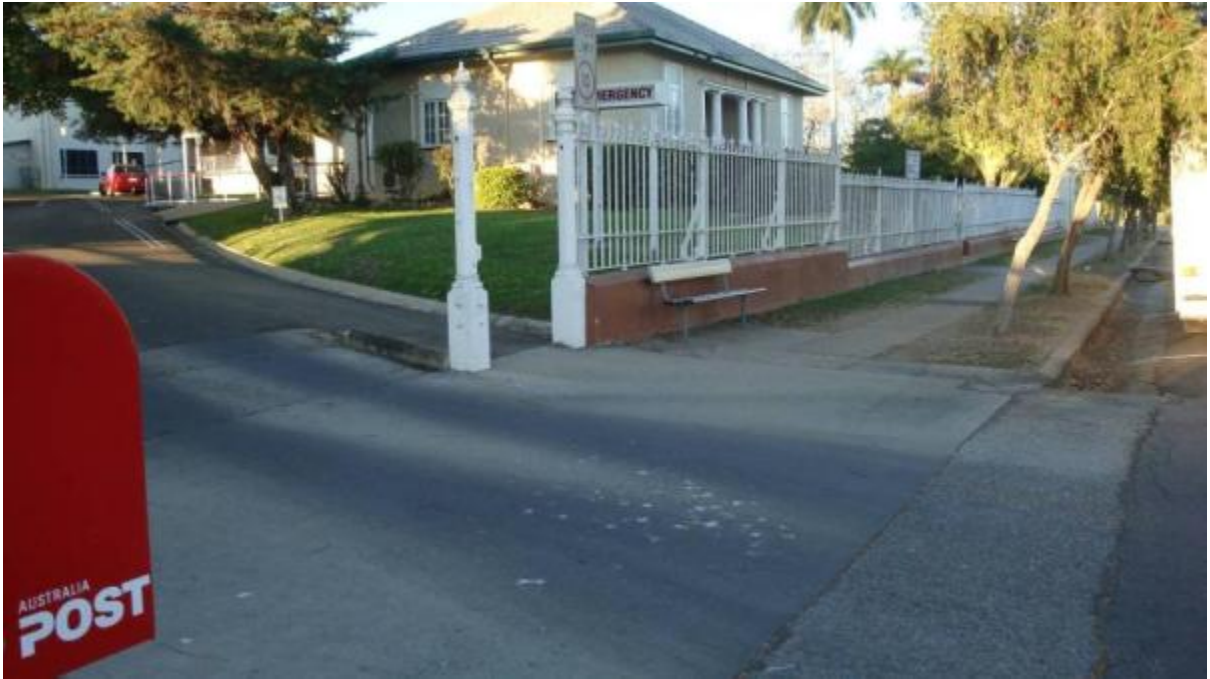
Photo 31

Principle driveway to hospital requires Hazard Tactile Ground Surface Indicators each side as per AS1428.4.

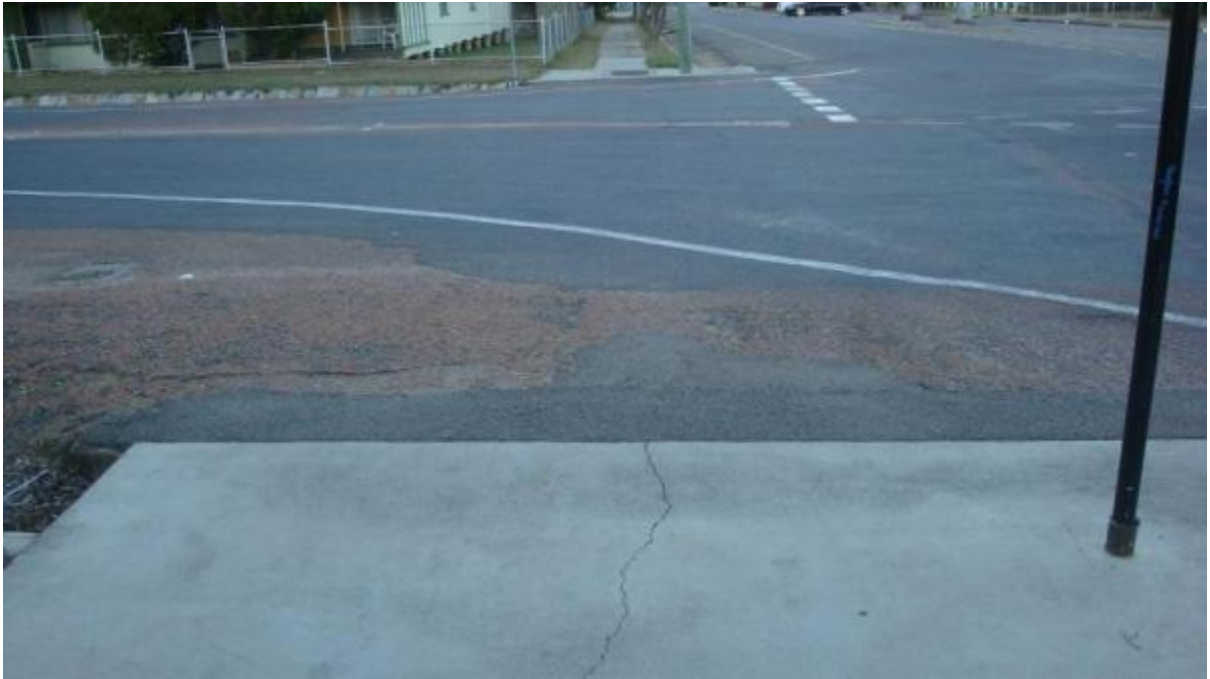
Photo 33

At Gill and Boundary Streets (north) both footpath to road transitions are rough and bordering on dangerous. They require re-grading and smoothing out. Compliant Hazard Tactile Ground Surface Indicators also required. Refer to AS 1428.4 and the referenced document 'Tactile Ground Surface Indicators and the Law'

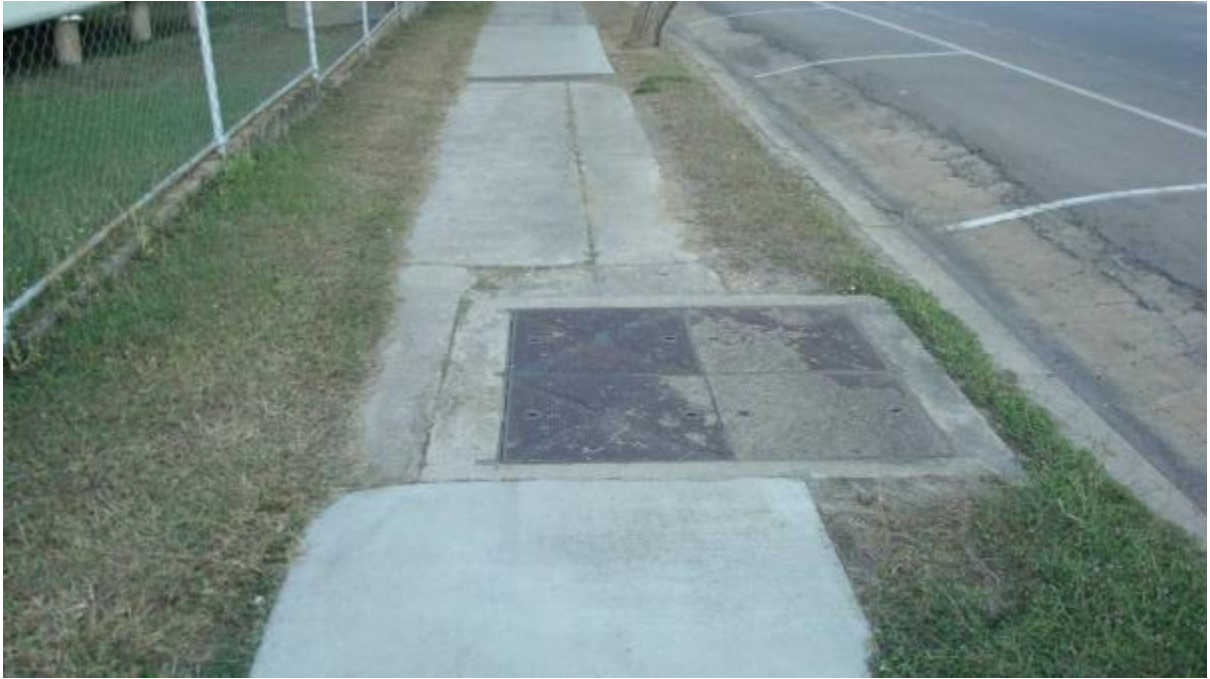
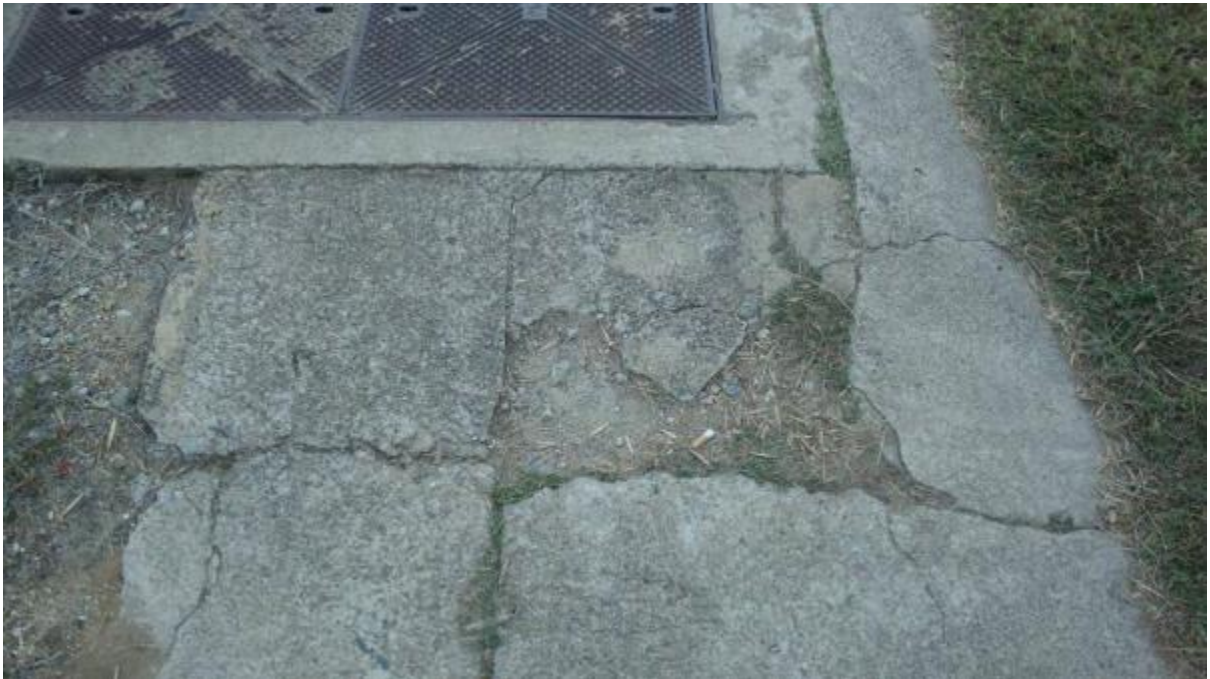
Photo 34 and 35

The Gill Street footpath, north side, between Boundary Street and the ambulance station requires repair and refurbishment. Currently a trip or tip over hazard and a liability risk.

The footpath is cracked, uneven and generally in poor condition.

Recommendation: Demolish it to eliminate the danger of injury.

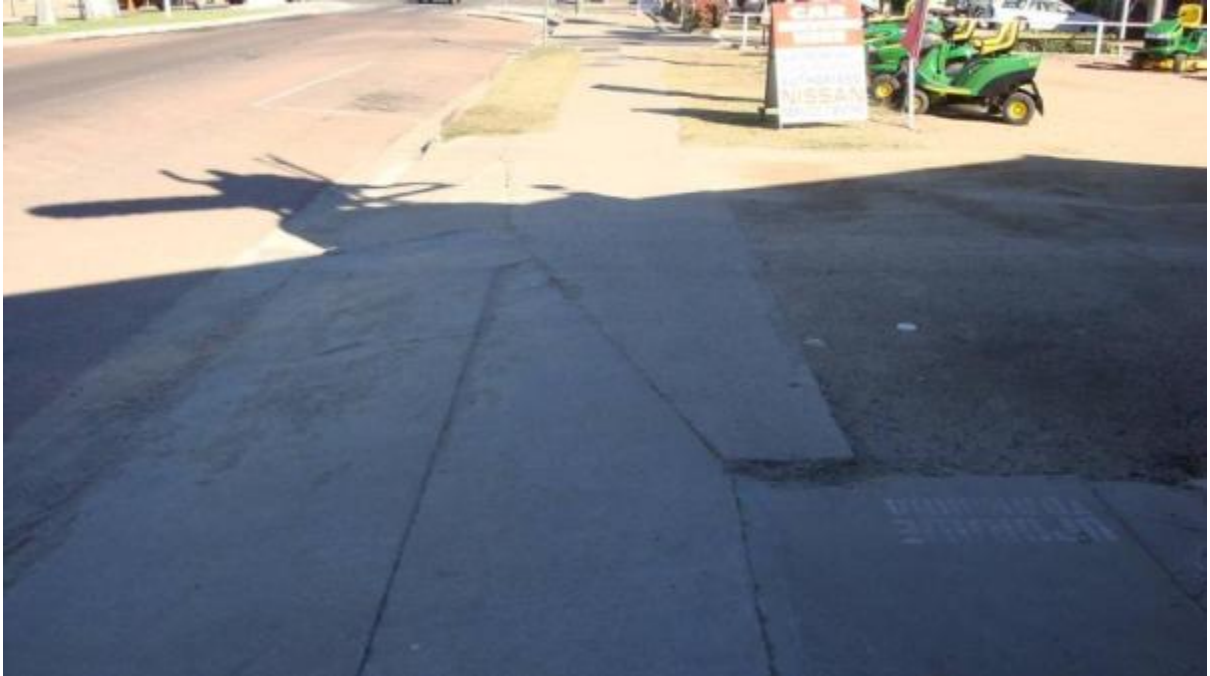
Photo 41

At the Towers driveway the footpath is broken and there is significant crossfall (noncompliant). It should be reviewed and an engineering solution provided in order to offer at grade pedestrian access.

Driveway Hazard Tactile Ground Surface Indicators required at 101 and 99 Gill Street. Also between 85 and 83, 81 and 79, 69 and 67. All in accordance with AS 1428.4

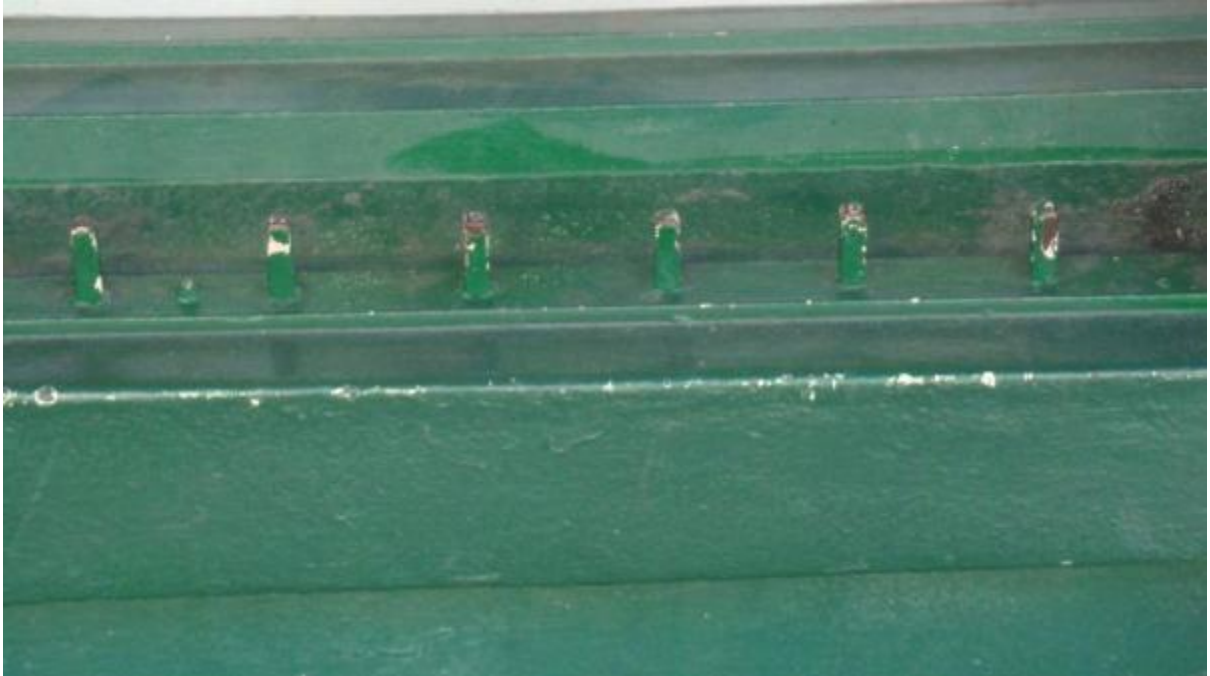
Photo 44

The spikes on the window ledges at Town Plaza can cause serious injury.

Consider referring to heritage architecture advisor for a solution to satisfy heritage and liability.

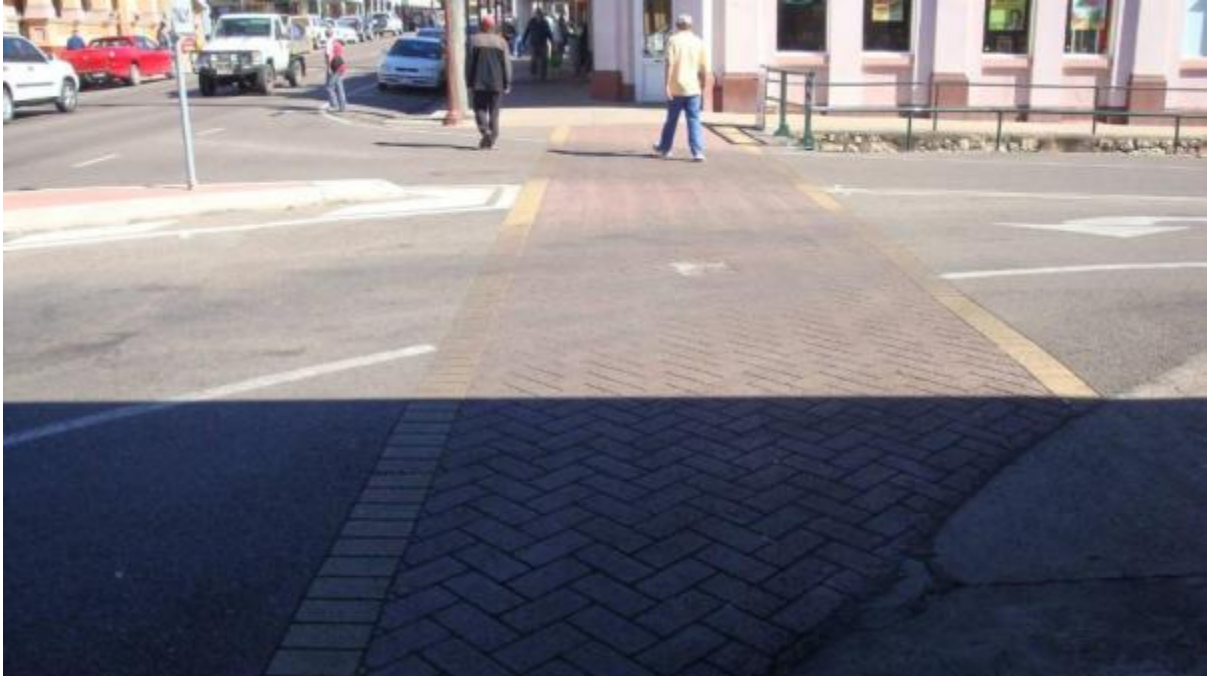
Photo 45

Gill and Deane Streets north side pedestrian crossing. Duplicate recommendations for south side.

Footpath to road transition requires installation of Hazard Tactile Ground Surface Indicators as per AS1428.4

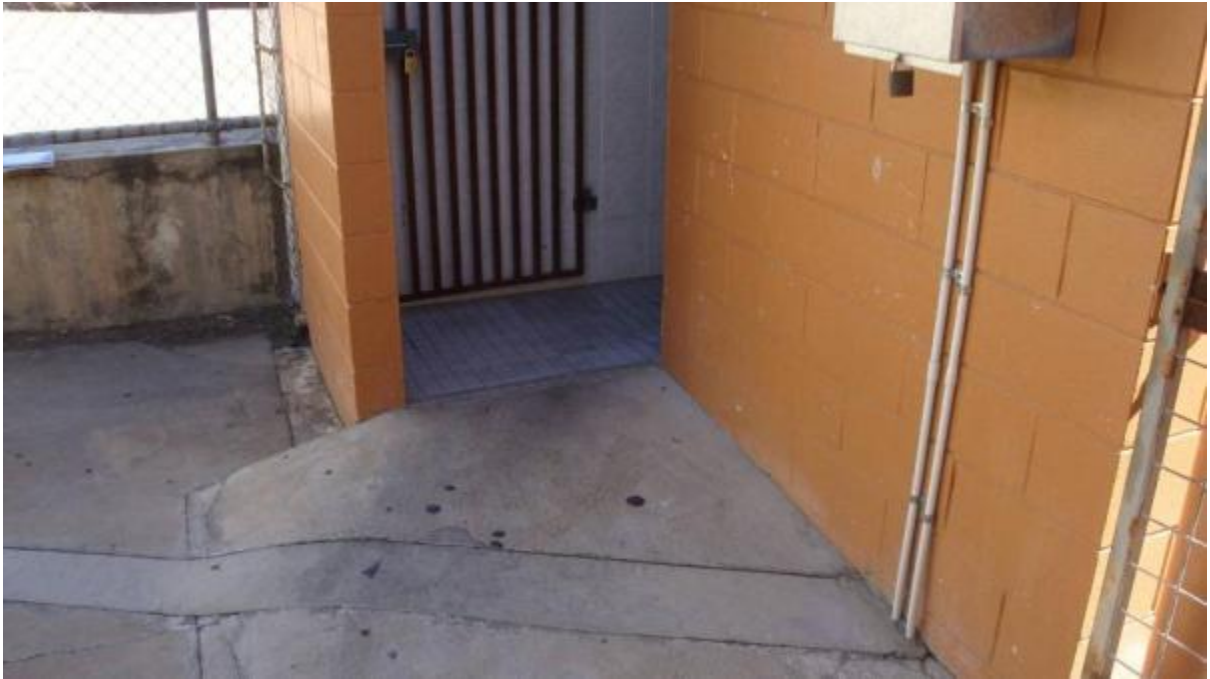
Photo 47

Many mobility device users would find this facility nonfunctional because they cannot get in. The depth for the L-shaped turning ark is 860mm. This, plus the poor pathway approach, is cause to refurbish the facility completely to meet compliance with AS1428.2.

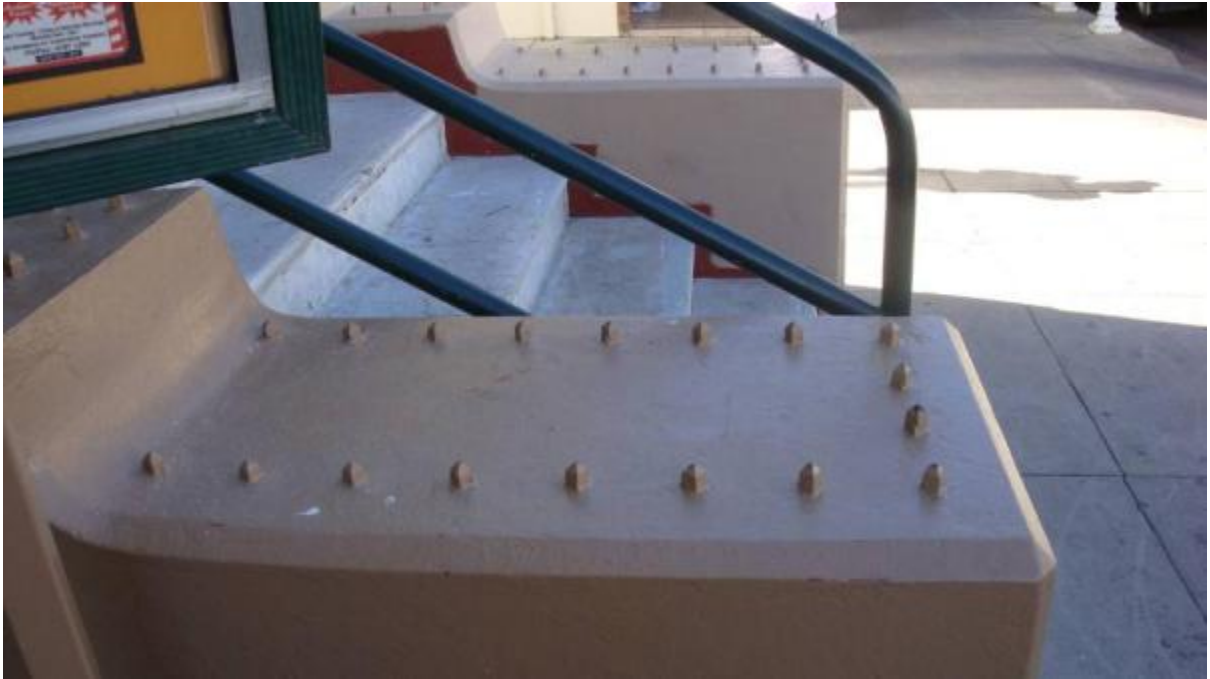
Photo 50

Driveway Hazard Tactile Ground Surface Indicators required between Westpac and Post Office. Comply with AS 1428.4

At the Post Office, vertical spikes on the building frontage protruding into public space can cause injury.

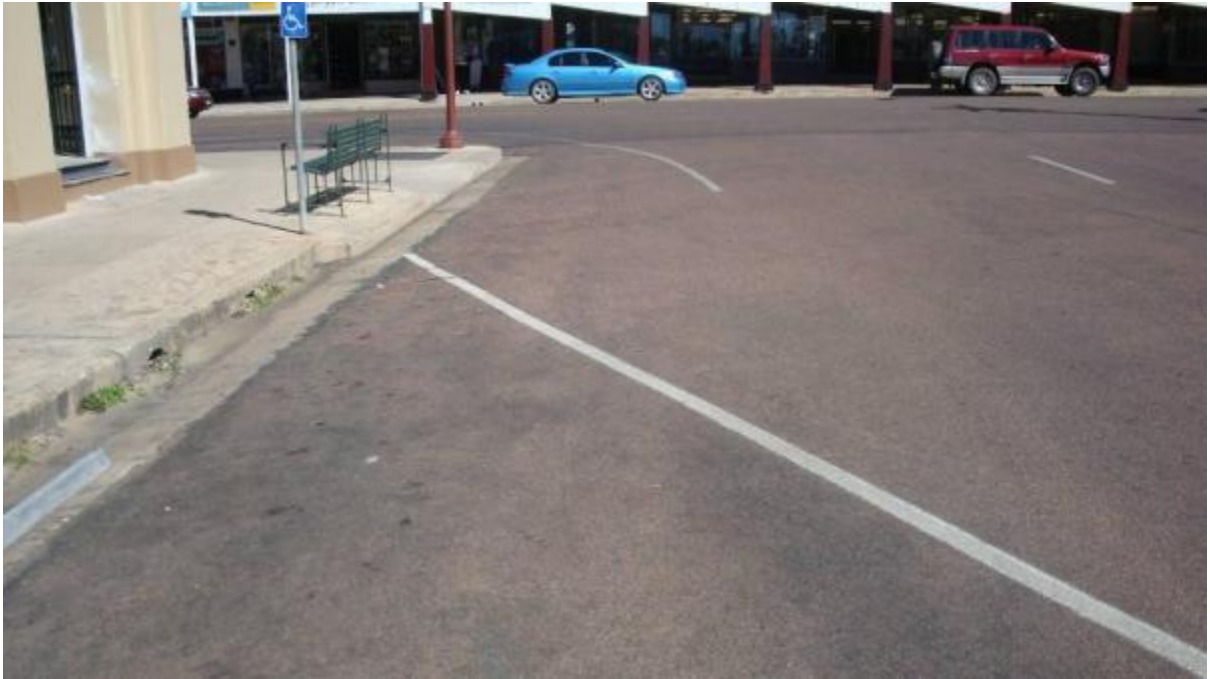
Photo 55

Some 13m north of the above bay, the raised service pit has produced a crossfall to the gutter that has the potential to cause public liability - engineering to inspect.

Recommend extending the curved line marking for vehicles closer to the disability parking bay to give greater assurance and intuitiveness for wheelchair users who have to wheel on the road to connect from their vehicle to the kerb ramp.

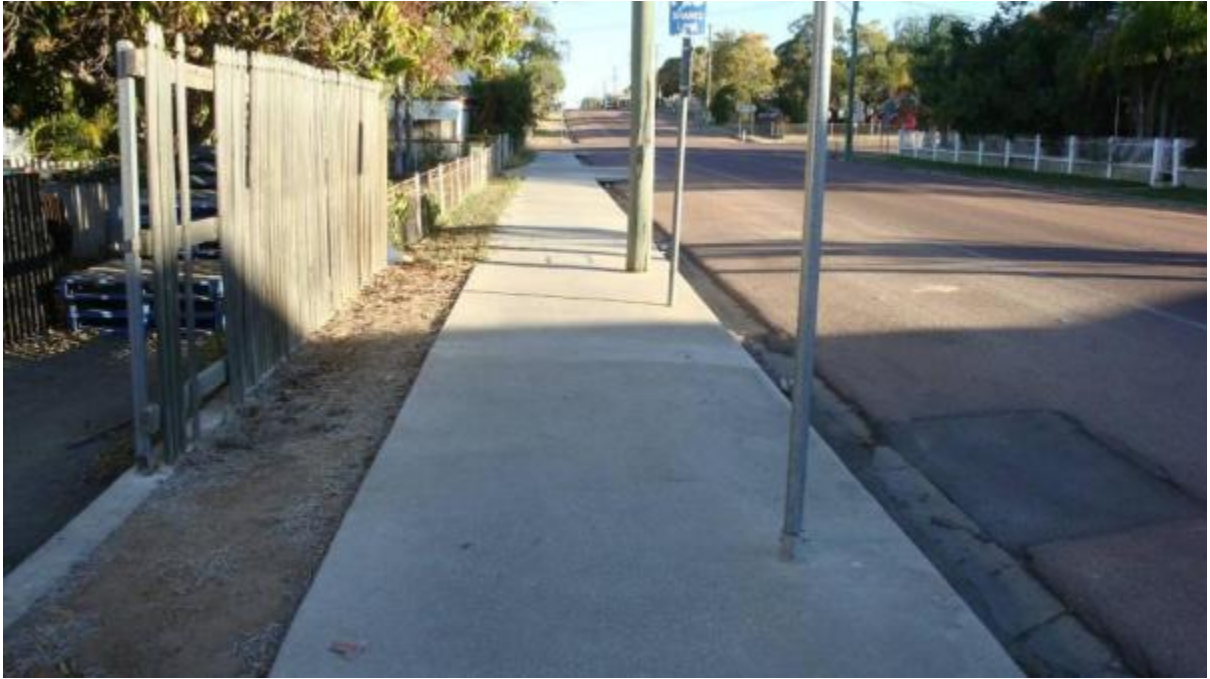
Photo 68

This side of the street is now a footpath of concrete construction. Given the Central State School requires an accessible path of travel to connect it to the community, recommend Council invest in continuing the concrete footpath to the school.

Install kerb ramps and Hazard Tactile Ground Surface Indicators in compliance with AS1428.2 from Hodgkinson Street to Aland Street.

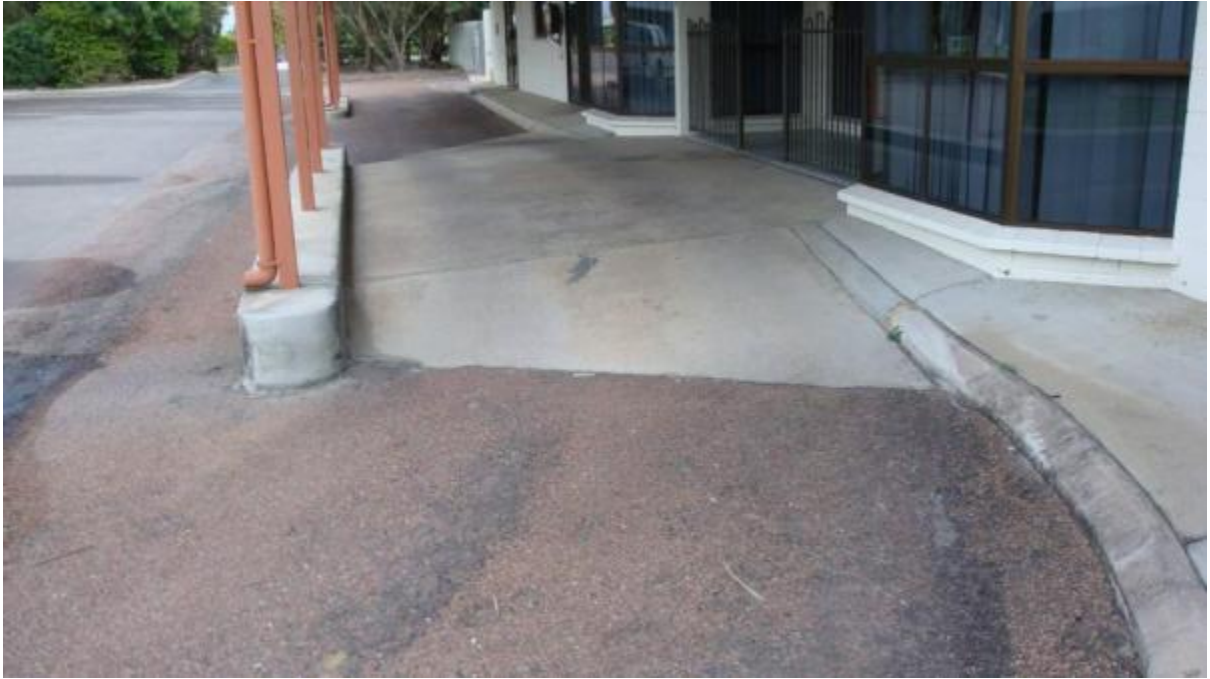
Photo 75

Council should plan to re-design the path of travel to the entry to the Day Respite Centre. Each end of the entry to the door is sloped, with gradients equal to ramp gradients yet there are no handrails (and there should be).

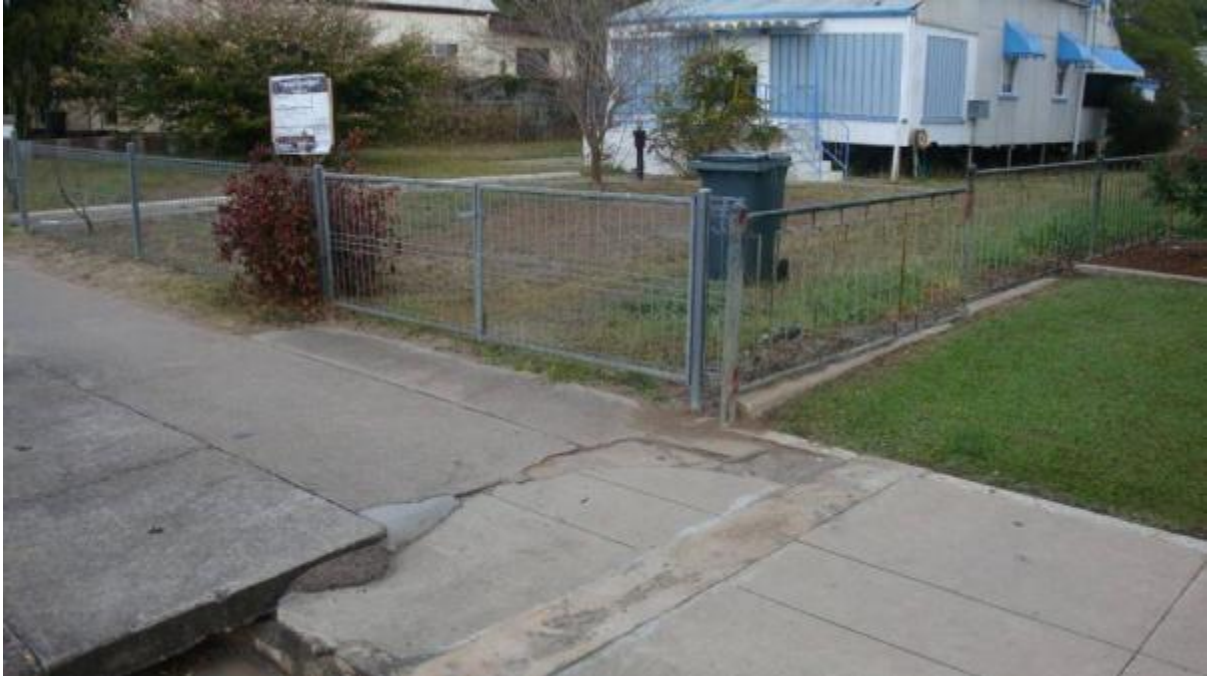
Photo 76

The footpath has a trip hazard where the Council building boundary joins the proposed car park (currently a residence). When it becomes a car park the driveway will require Hazard Tactile Ground Surface Indicators in compliance with AS 1428.4..
