Access Report for Charters Towers

Charters Towers QLD 4816

**A report by:
John Mayo
Access Solutions
109 Logan Rd
Woolloongabba 4102
Phone: (07) 3391 2044
Fax: (07) 3391 2088**

Executive Summary

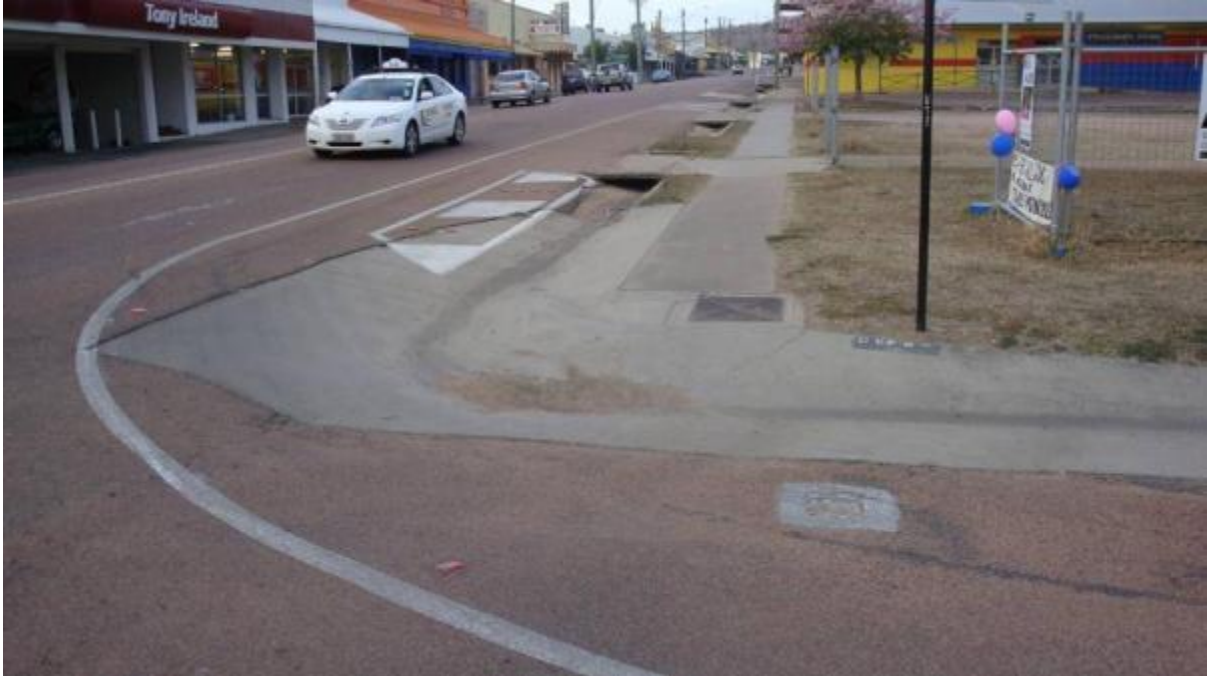
Photo 79

The kerb ramp at the south west corner of Mary Street is nonfunctional for mobility device users due to its steepness. The recommended gradient is 1:9 or less. Redesign and re-grade. Go to checker plate or expanded mesh if you have to in order to achieve compliant gradient.

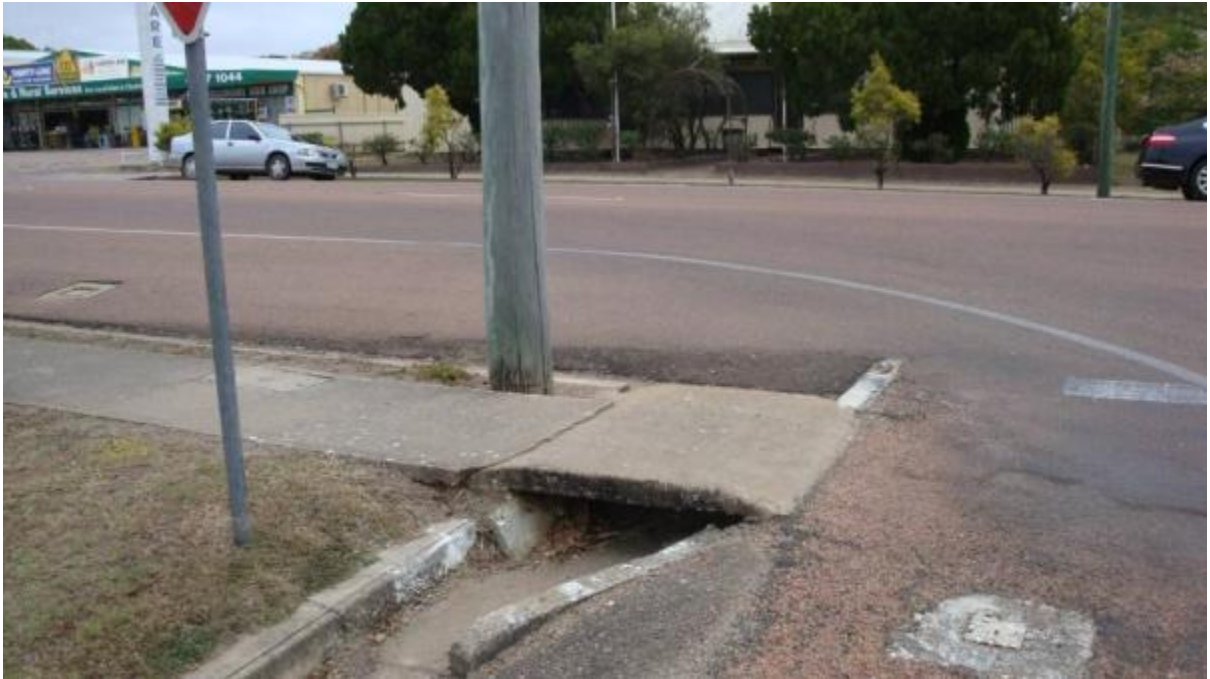
Photo 94

At the south east corner of Ann Street, the bridging ramp connecting to the road is old and requires refurbishment to meet compliance with AS1428.2.
