Access Report for Charters Towers

Charters Towers QLD 4816

**A report by:
John Mayo
Access Solutions
109 Logan Rd
Woolloongabba 4102
Phone: (07) 3391 2044
Fax: (07) 3391 2088**

Executive Summary

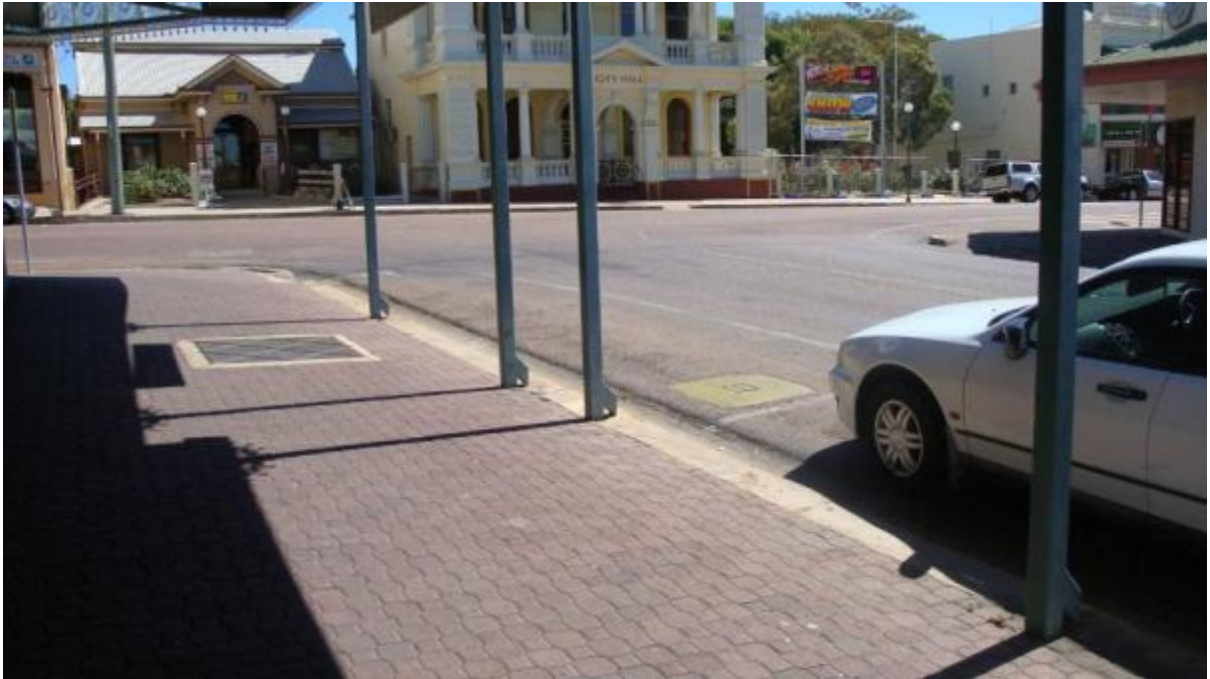
Photo 1

Audit trail: proceeds along Gill Street south side from Stan Pollard Store.

The recommended alternative is controlled signalized pedestrian crossings. One across Gill Street and one across Mosman Street connecting to the City Hall.

All 4 existing kerb ramps to be refurbished to meet compliance with AS1428.2-1992. clause 8.4

Engineering to check underground services to ensure kerb design compliance can be achieved.

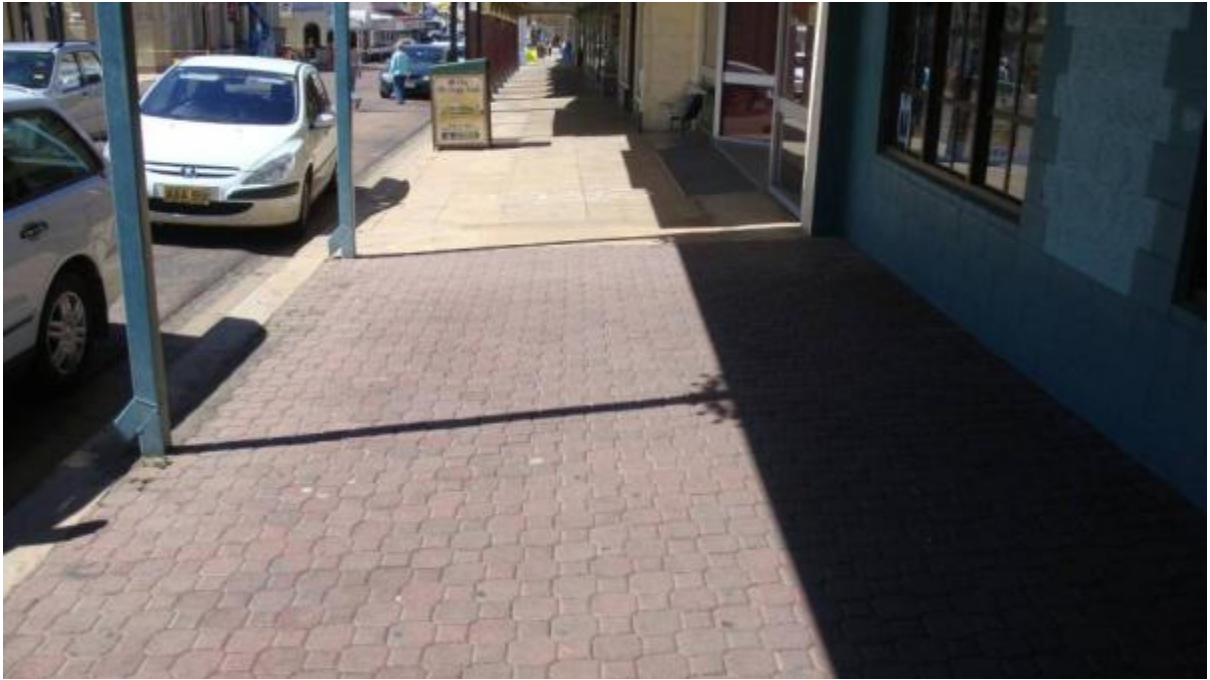
Photo 2

The footpath in Gill Street is a variety of surfaces, uneven in parts, with significant crossfall in parts.

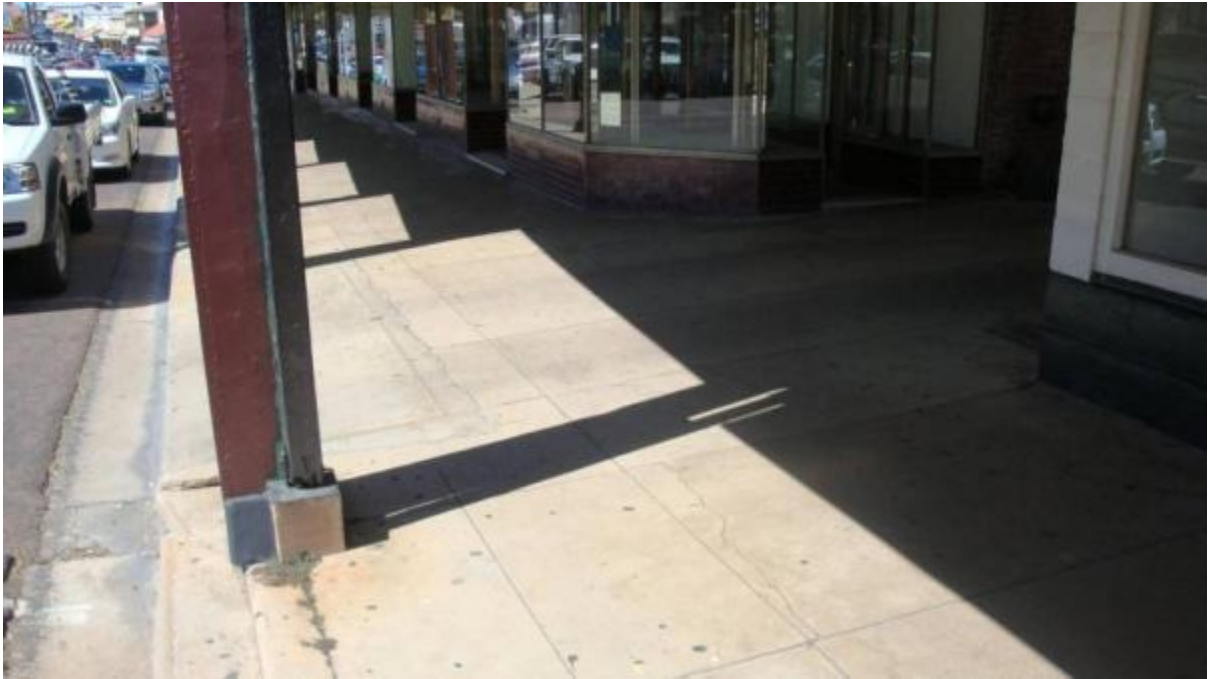
Photo 3

The driveway adjacent to Target Country store requires warning tactile ground surface indicators in accordance with AS 1428.4 to each side of the driveway.

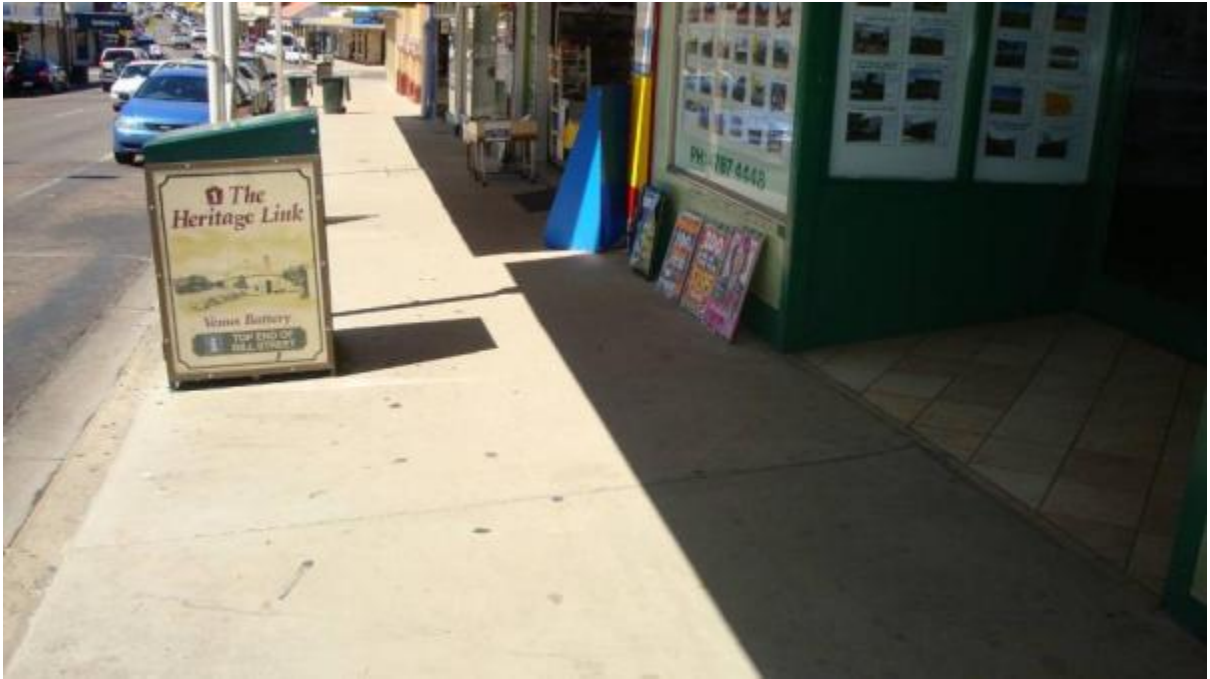
Photo 4

Rubbish bins are large. Their depth bites into pedestrian circulation space. Consider slimmer design for the future. In the interim, can bin rear door and aperture be successfully accessed if mounted parallel with the kerb?

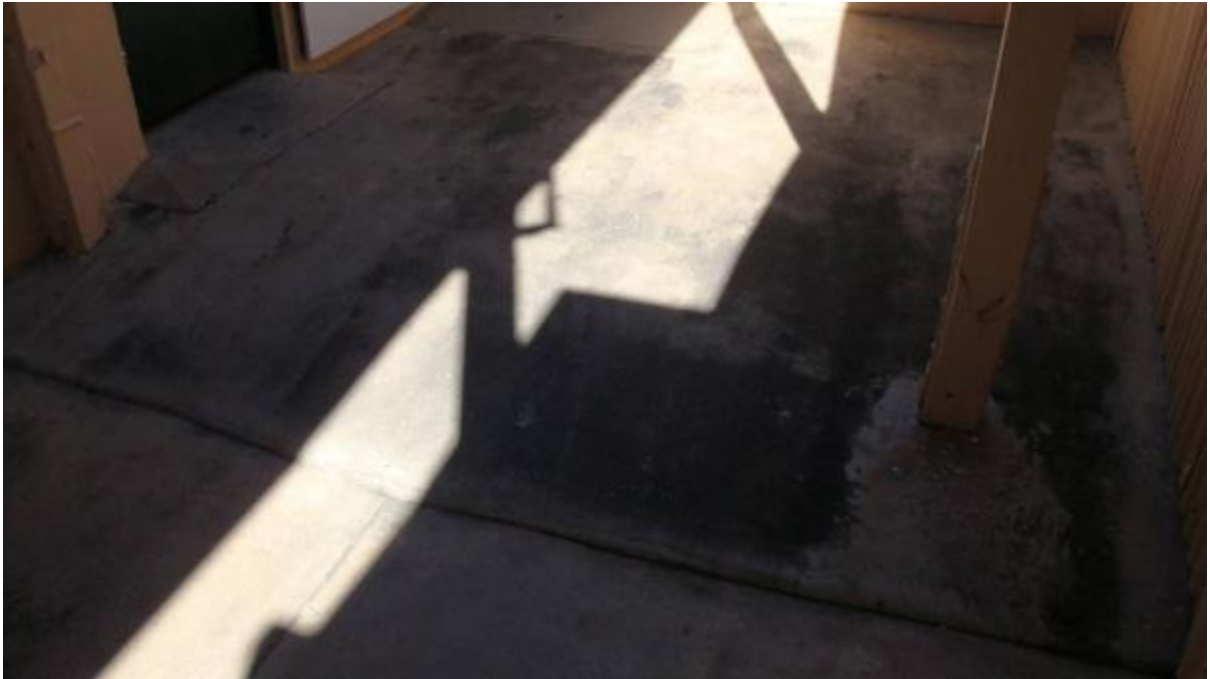
Photo 6

The approach path of travel to the toilet door of the accessible unisex toilet requires significant re-grading. The area in front of the door should be flat – even the area of transition between the existing at grade level and the lip before the two upright posts requires re-grading so that the lip is no greater than 3mm.

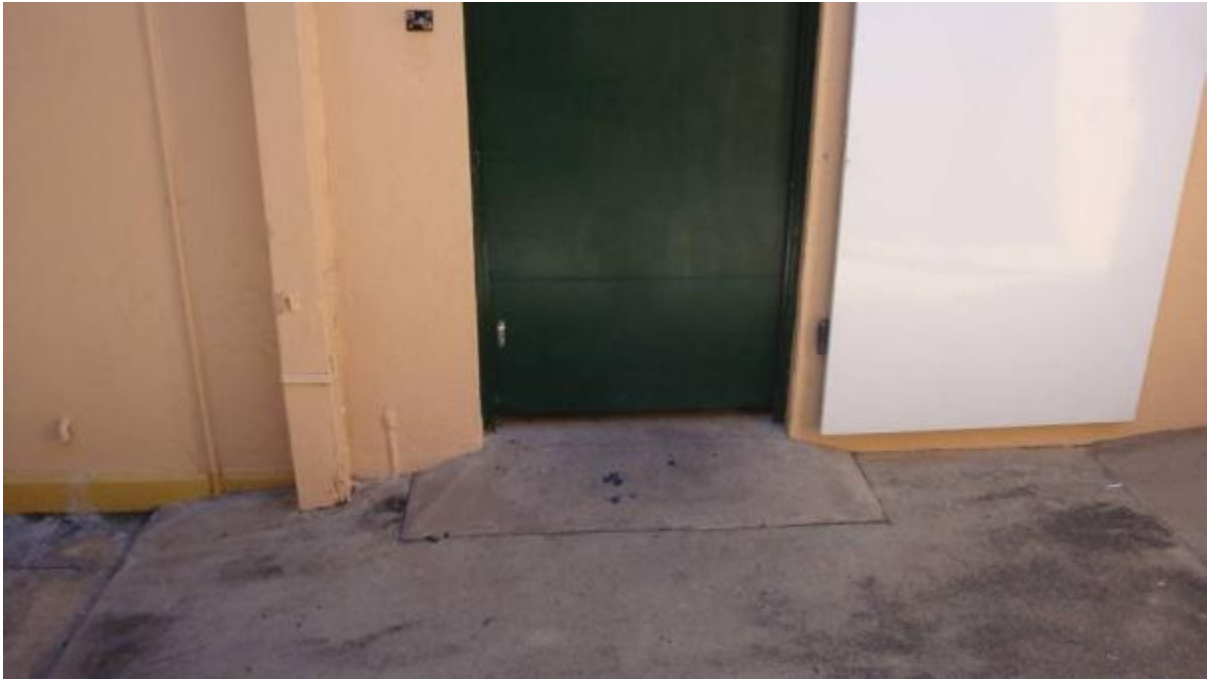
Photo 7

Toilet door is too narrow. 850mm clear opening is required to be compliant with AS 1428.2 – 1992. Door currently measures 750mm wide.

The existing door threshold is ramped. A level threshold at the door is recommended.

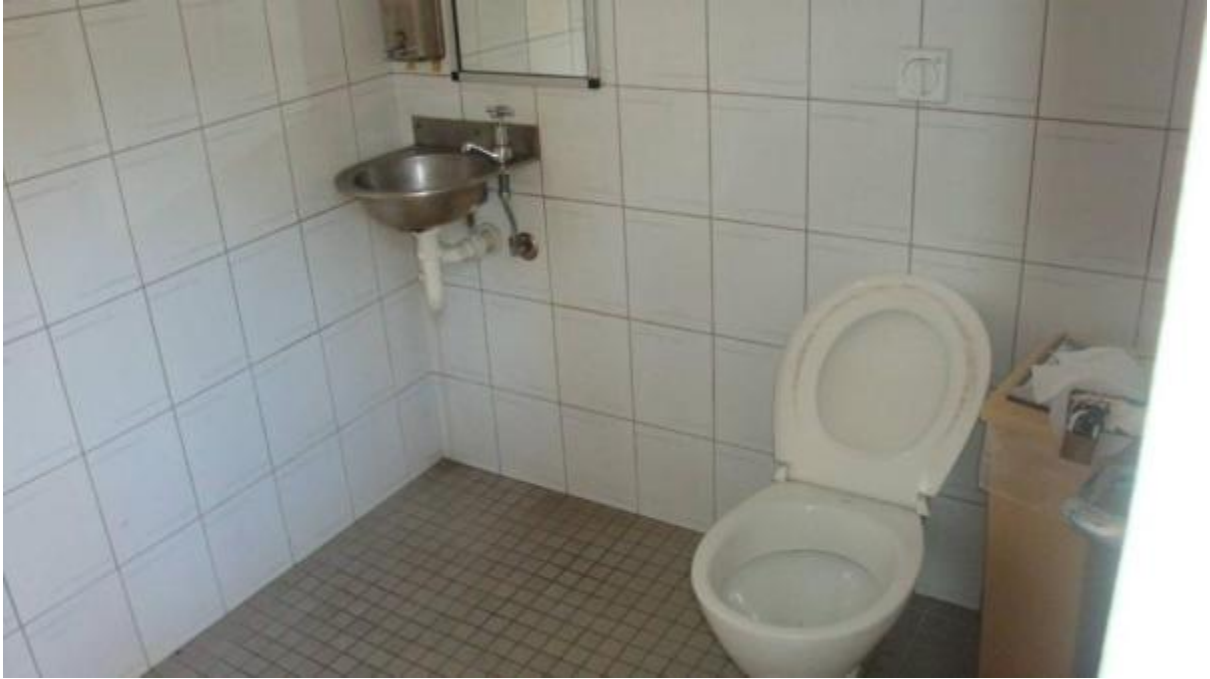
Photo 9

Hand basin in 90 degree corner. Relocate.
Upgrade to comply with AS1428.2 – 1992.

Refer to 'Accessible unisex toilets, showers, turning circle', included in the accompanying referenced documents.

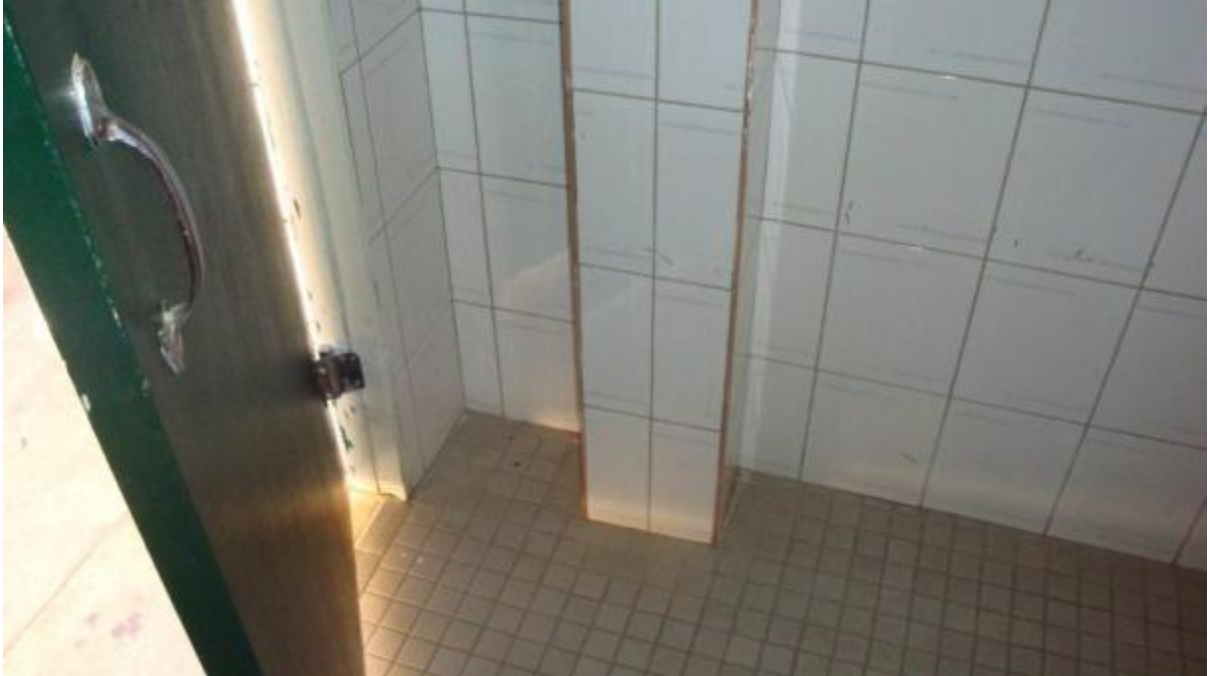
Photo 10

Room is $1700\text{mm} \times 1560 + 1150 = 2710\text{mm}$ long, and there is a 170mm deep tiled protrusion into the space behind the door which may house a down pipe or electrical service (no evidence of what it is).

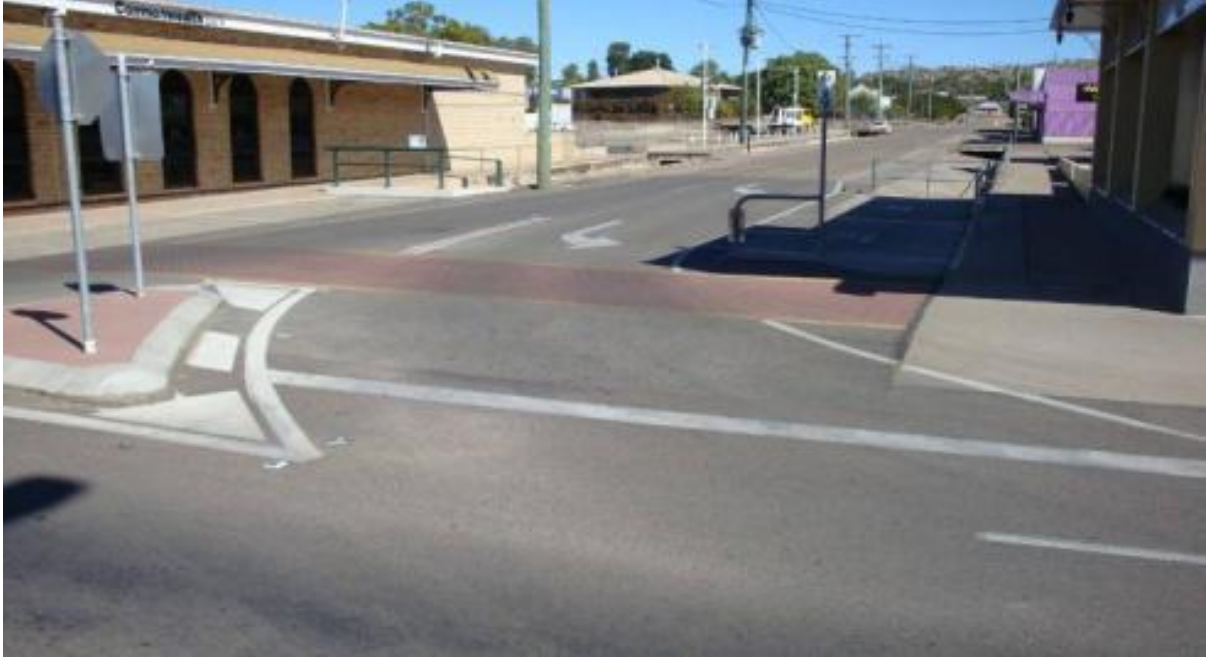
Photo 13

Pedestrian crossing connecting ANZ Branch with CBA, corner Gill and Deane Streets.

Footpath to road transition requires installation of Hazard Tactile Ground Surface Indicators as per AS1428.4

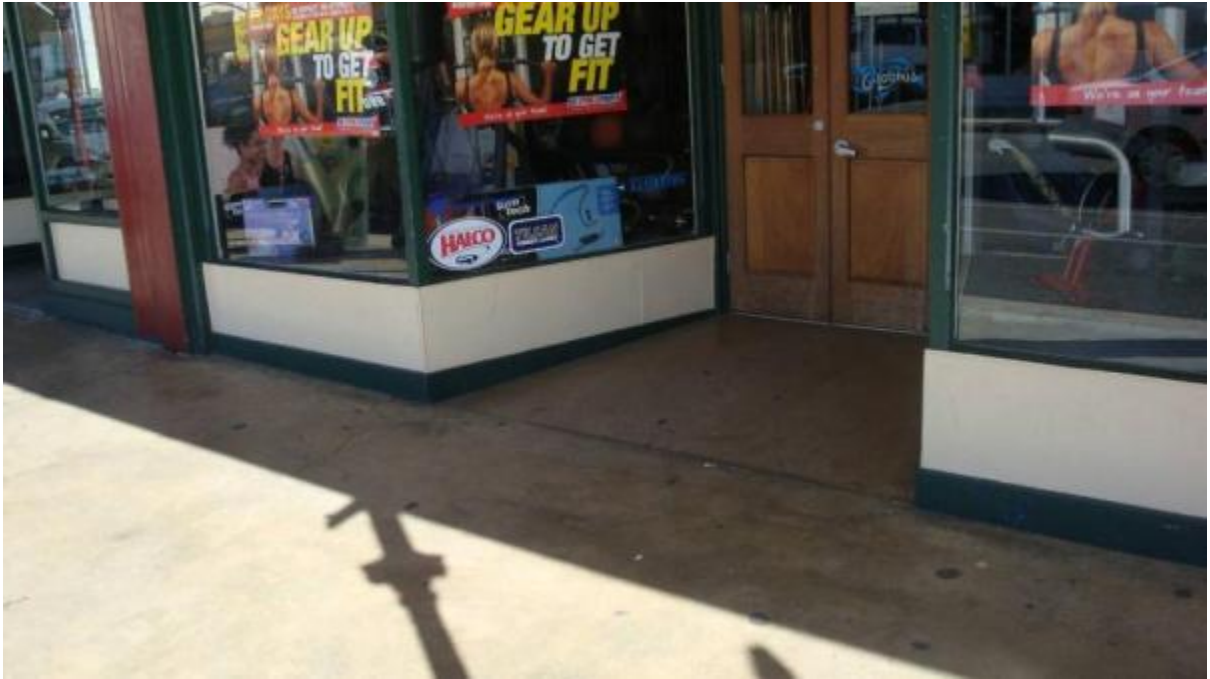
Photo 18

Gently graded access into some stores is well done. Two entries into Sports Power store are examples.

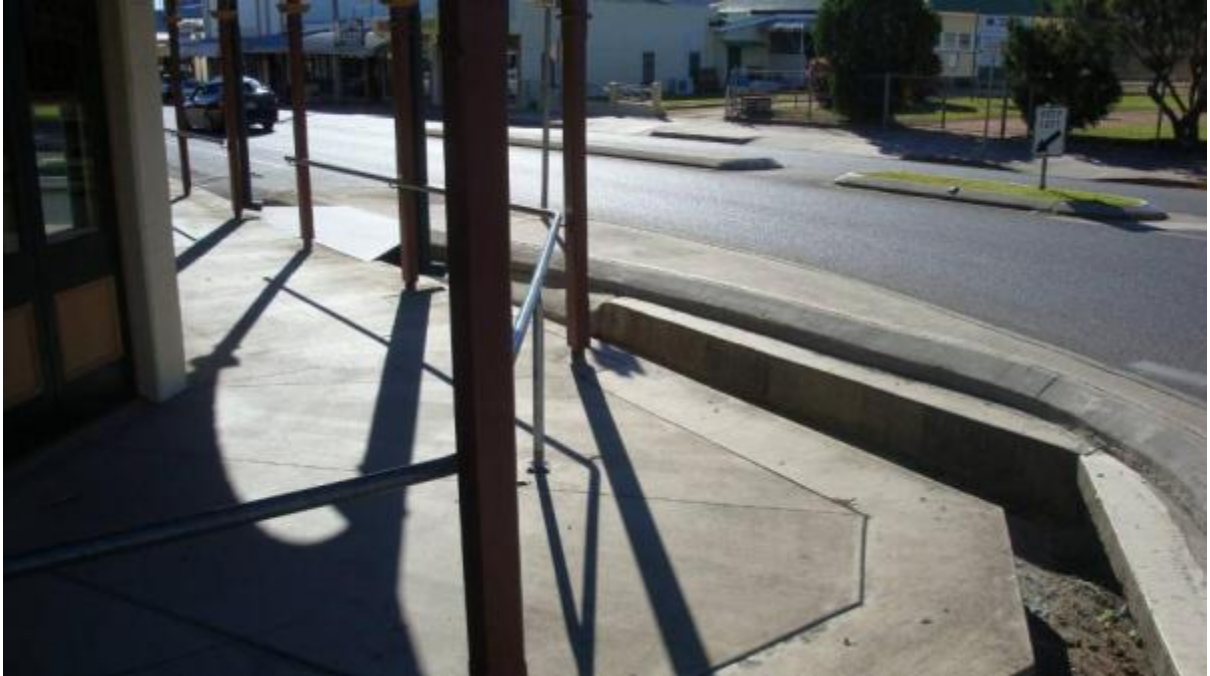
Photo 19

Pedestrian crossing connecting Library to Uniting Church.

The kerb ramp crossing transitions require Hazard Tactile Ground Surface Indicators at the top of the kerb ramp to comply with AS1428.2 – 1992. Refer also to the referenced document 'Tactile Ground Surface indicators and the law'

The crossing is heavily influenced by vehicular traffic able to go straight ahead or turn left or right from either Gill or Church Streets. If that rite of passage is to be maintained for motorists as is, it minimises the safe crossing options for pedestrians.

The deep trenches around the Library corner of Church and Gill Street also limit options. These trenches are hazardous. Consider installing expanded metal mesh or grated covers to reduce danger of injury and litigation.

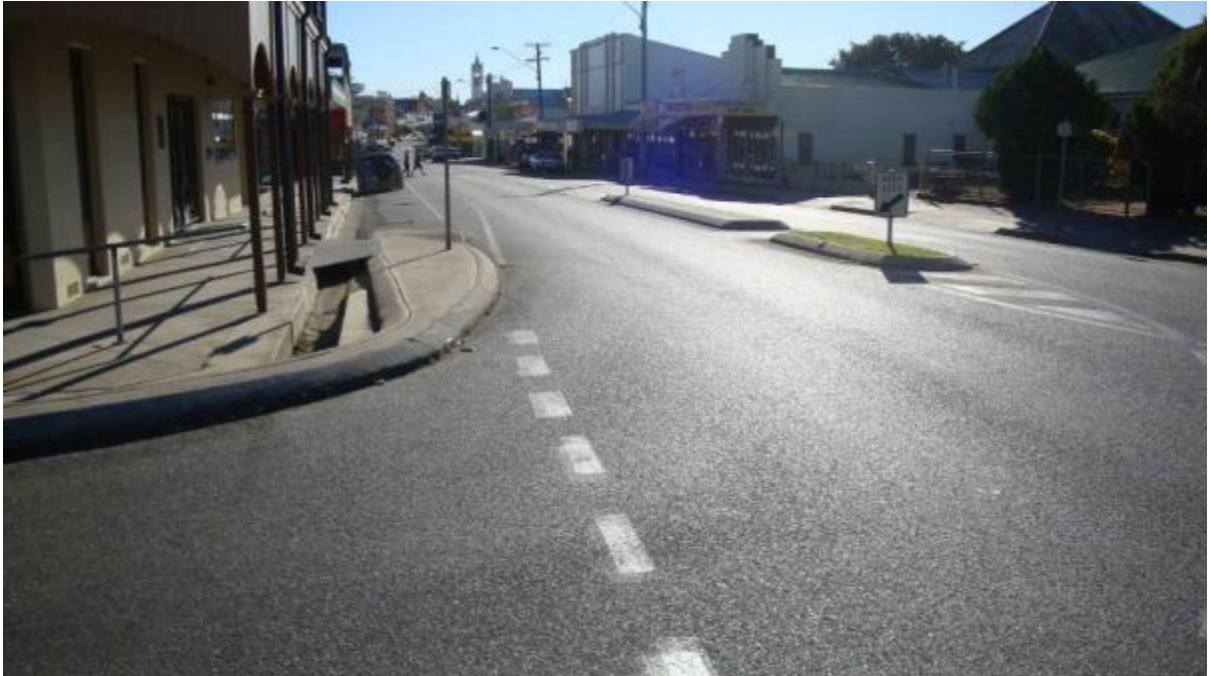
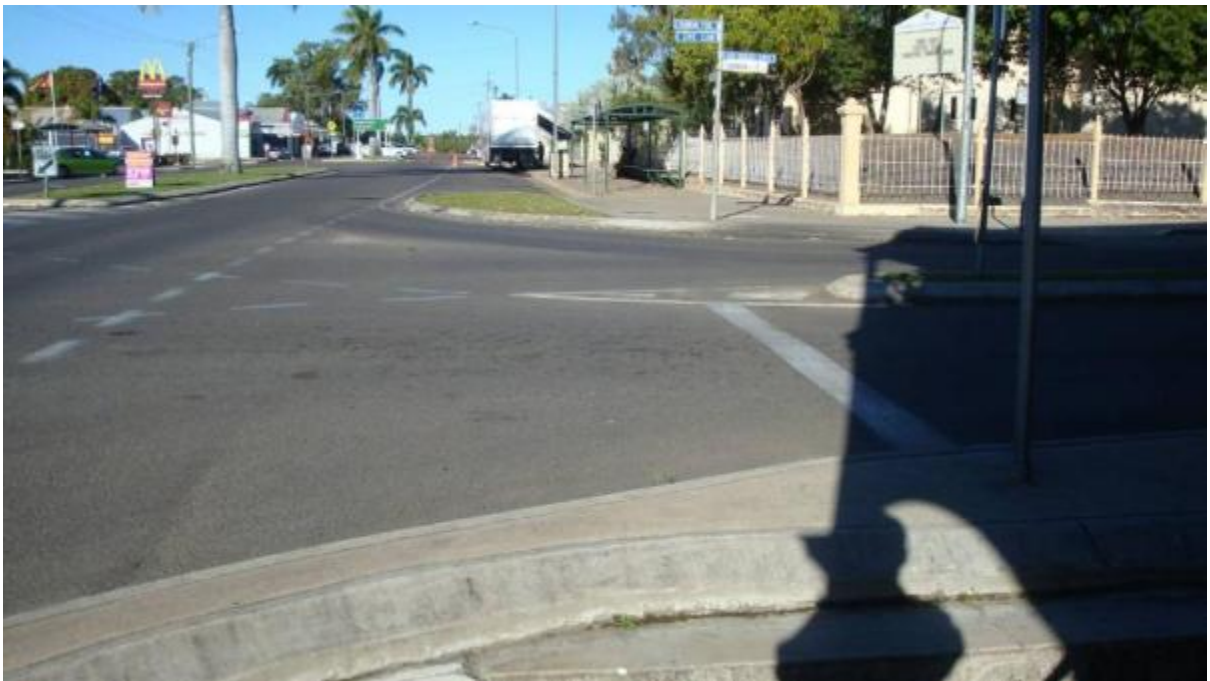
Photos 20 and 21

The library entry crossing is close to the intersection, approximately 8m from Church Street.

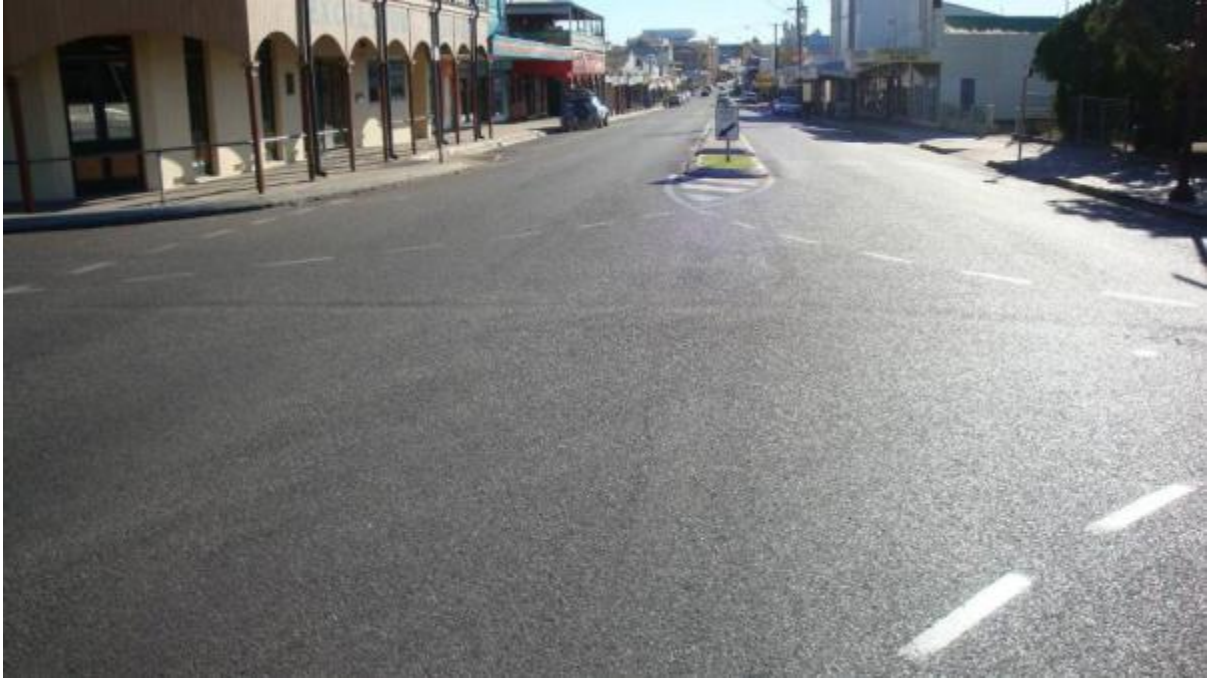
Photo 22

The compulsory stop signage and wide line marking in Church Street (south and north) needs to advance closer to Gill Street to maximise vision for motorists.

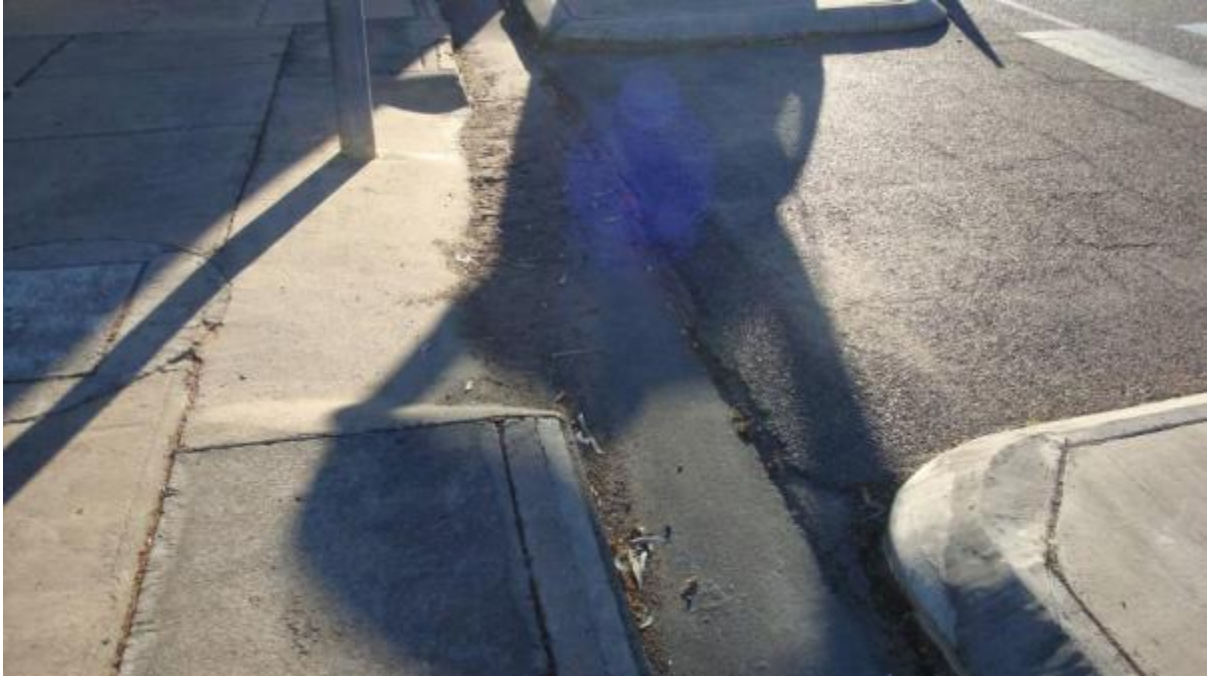
Photo 25

Pedestrian crossing connecting McDonalds and St Columba's Church.

Re-grade the footpath to road transitions on both sides of Gill Street to 1:9 or gentler.

The kerb ramp crossing transitions require Hazard Tactile Ground Surface Indicators at the top of the kerb ramp to comply with AS1428.2 - 1992.

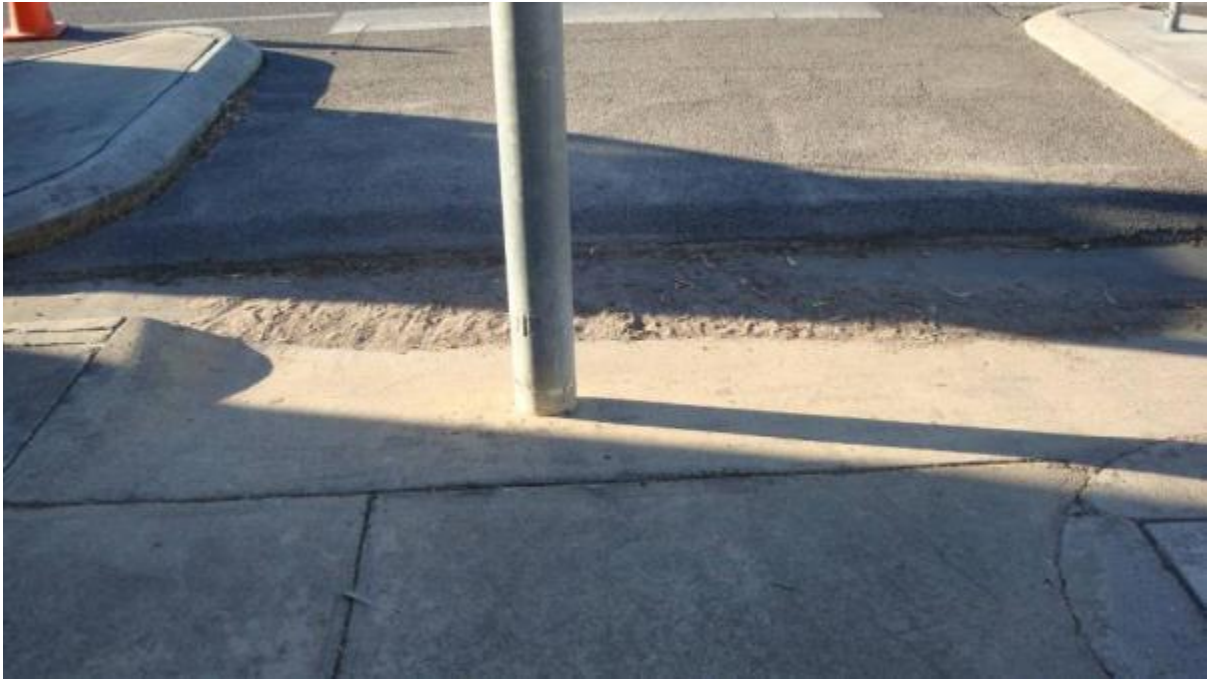
Photo 26

If the pole in the centre of the kerb ramp cannot be removed from the St Columba's crossing, paint it safety yellow to minimise public liability.

Provide effective luminance and colour contrast between ground surface and pole. AS 1428.2-1992 calls for 30% contrast. Refer to the 'Luminance contrast tool' and 'Luminance contrast between AS2700-1996 standard colours' which identifies 30%, 45% and 60% contrast.

Install Hazard Tactile Ground Surface Indicators at the top of the kerb ramp to comply with AS1428.2 – 1992.

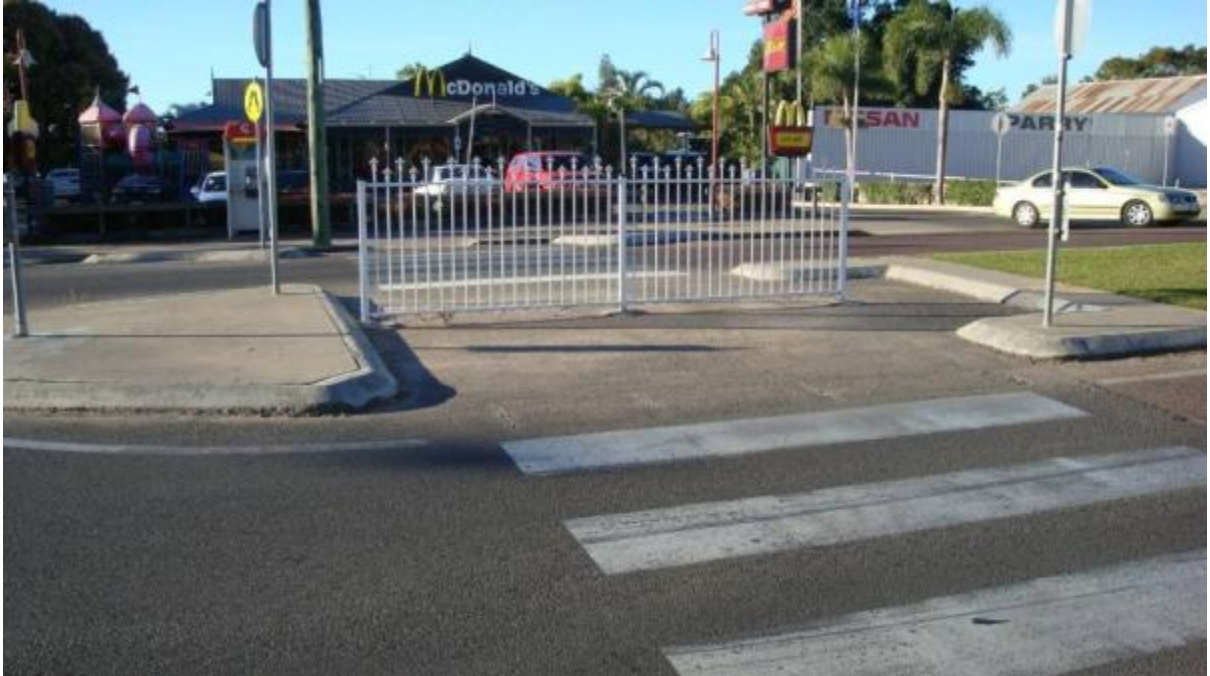
Photo 27

The 'lace' gate in the median strip is too wide. Remove half the width and relocate the remaining section so as to be centered, allowing users to go around either side of it. Engineering may consider the entire gate to be redundant. Or simply remove left hand panel as viewed in this photo.

Install Hazard Tactile Ground Surface Indicators to comply with AS1428. –1992.

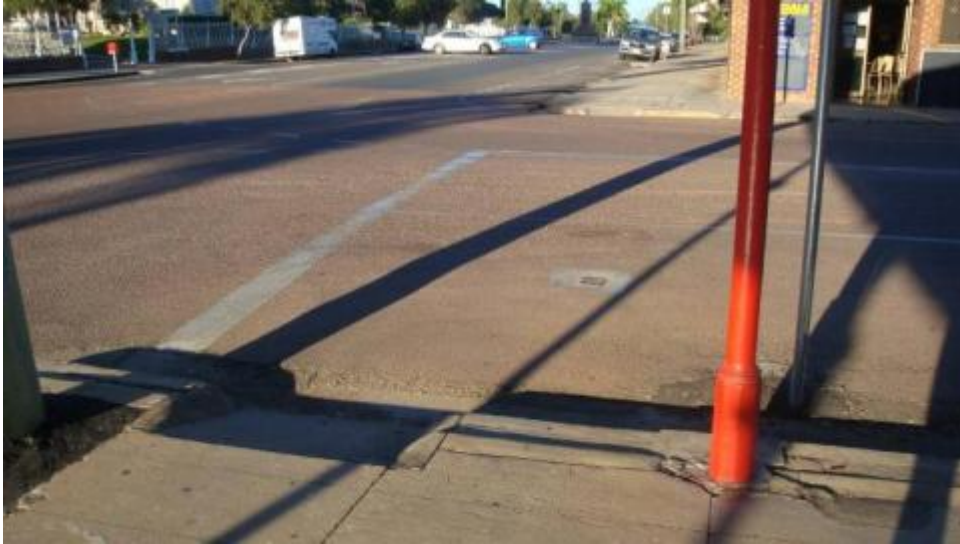
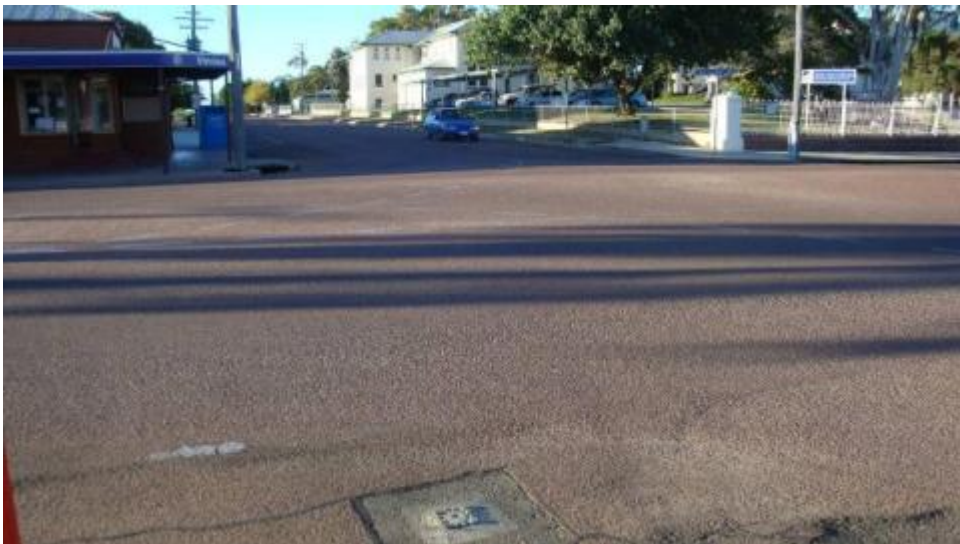
Photos 29 and 30

Pedestrian crossing Gill and High Streets. Existing characteristics:

Install kerb ramps as AS1428.2-1992 with Hazard Tactile Ground Surface Indicators connecting Elders to Vinnies, Elders to Tavern, and Tavern to hospital. Install Hazard Tactile Ground Surface Indicators from Vinnies to hospital.

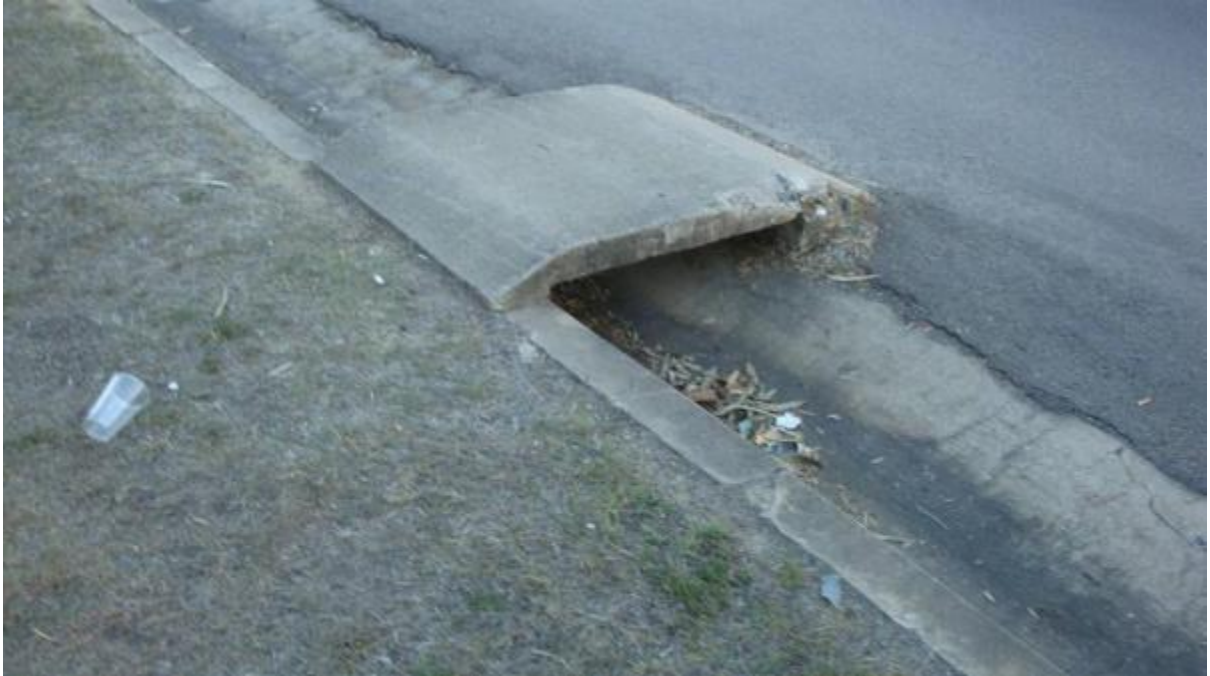
Photo 32

Nonconforming ramps such as the example photographed 30m east of the hospital entry simply pose a public liability risk for council.

Recommendation: Demolish it to eliminate the danger of injury.

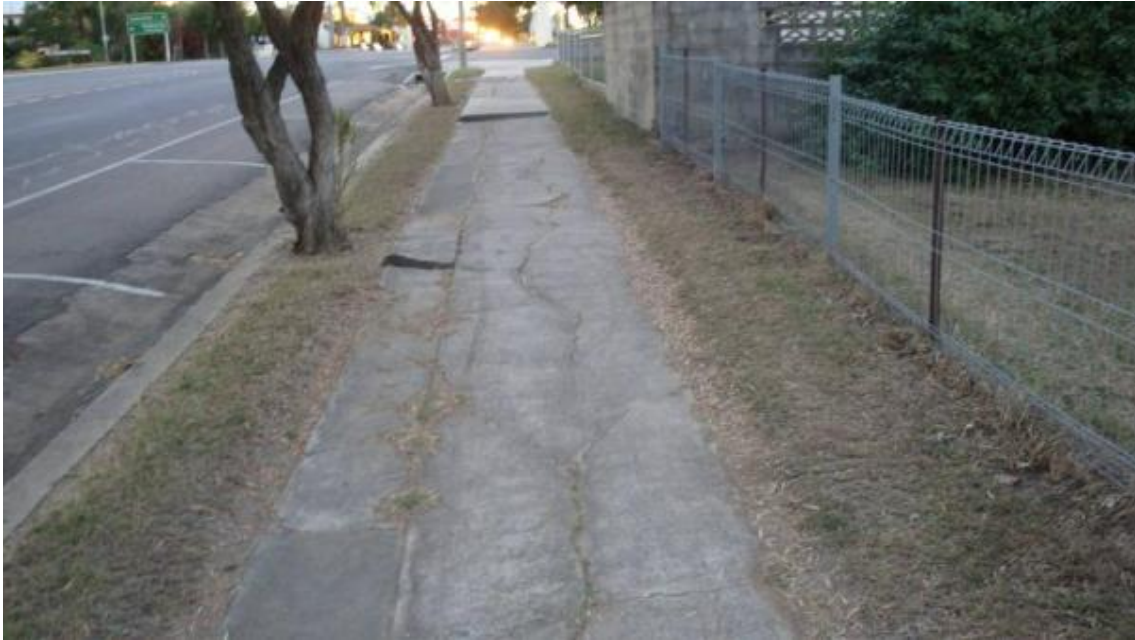
Photo 36

The footpath is cracked, uneven and generally in poor condition.

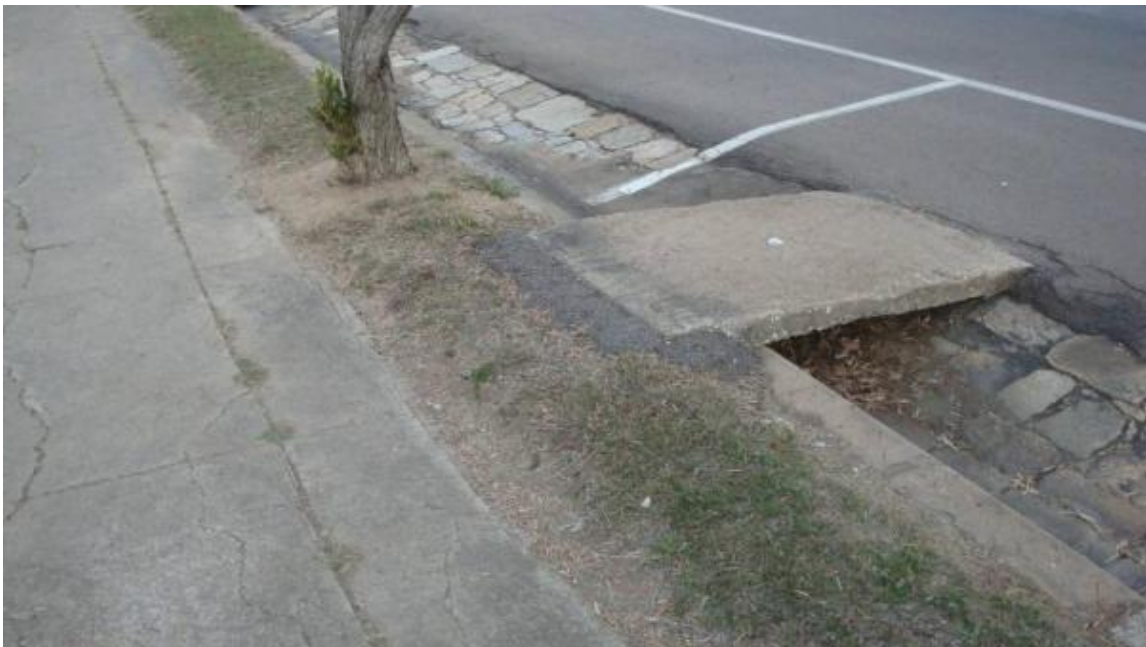
Photo 37

Another nonconforming pedestrian ramp outside property no.143 Gill Street. Nonconforming ramps such as the example photographed 30m east of the hospital entry simply pose a public liability risk for council.

Recommendation: Demolish it to eliminate the danger of injury.

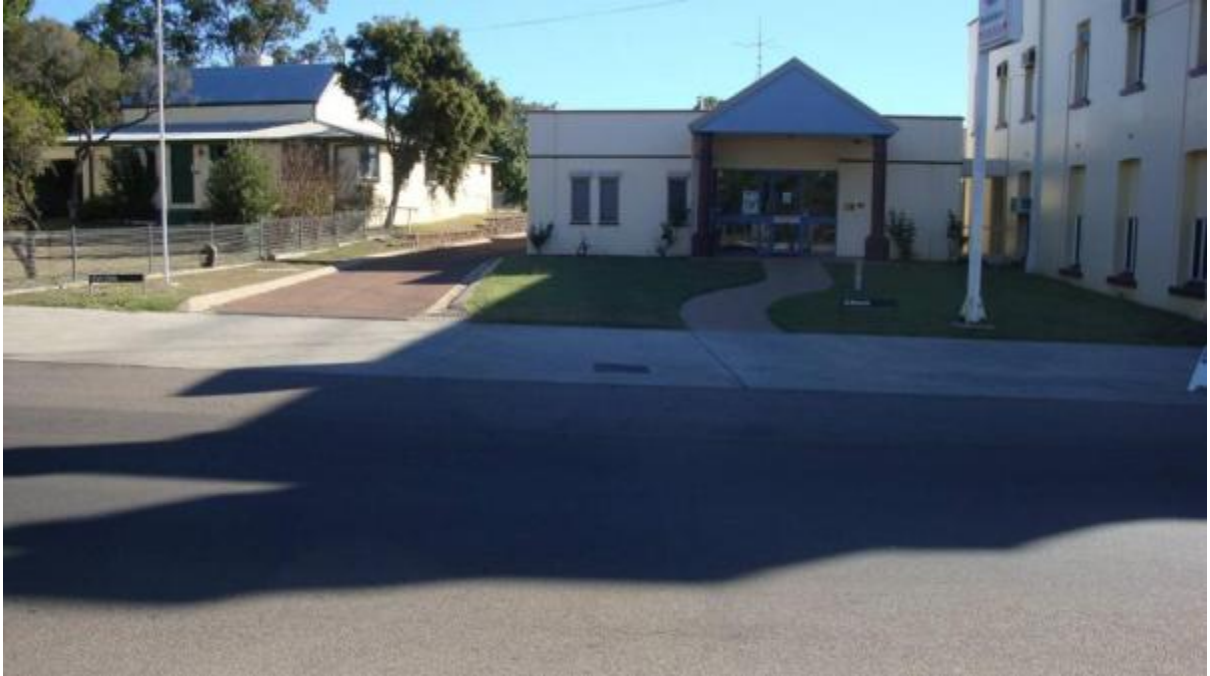
Photo 38

Ambulance office and museum parking:

There is on-street space for parking on an apron in front of these buildings. This area has some parking nearby but not disability parks. The consultant spoke to ambulance administrator who said the ambulance service would welcome line marking for disability and conventional bays in front of their buildings.

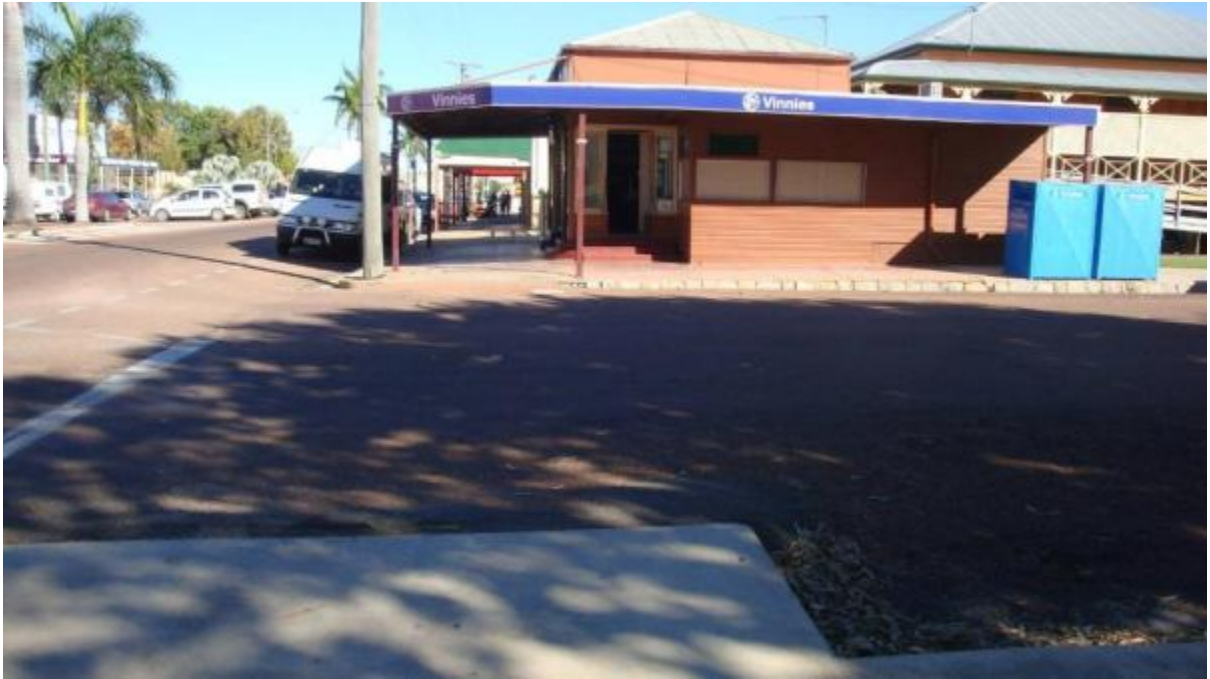
Photo 40

Audit trail: Gill Street north side from High Street to Mosman Street.

Hazard Tactile Ground Surface Indicators complying with AS1428.4 required at footpath to road transitions between hospital and Vinnies.

At driveway between 131 and 129 Gill Street Hazard Tactile Ground Surface Indicators complying with AS1428.4 are required. Also at Towers Power Equipment and the two driveways at McDonalds and the Caltex service station.

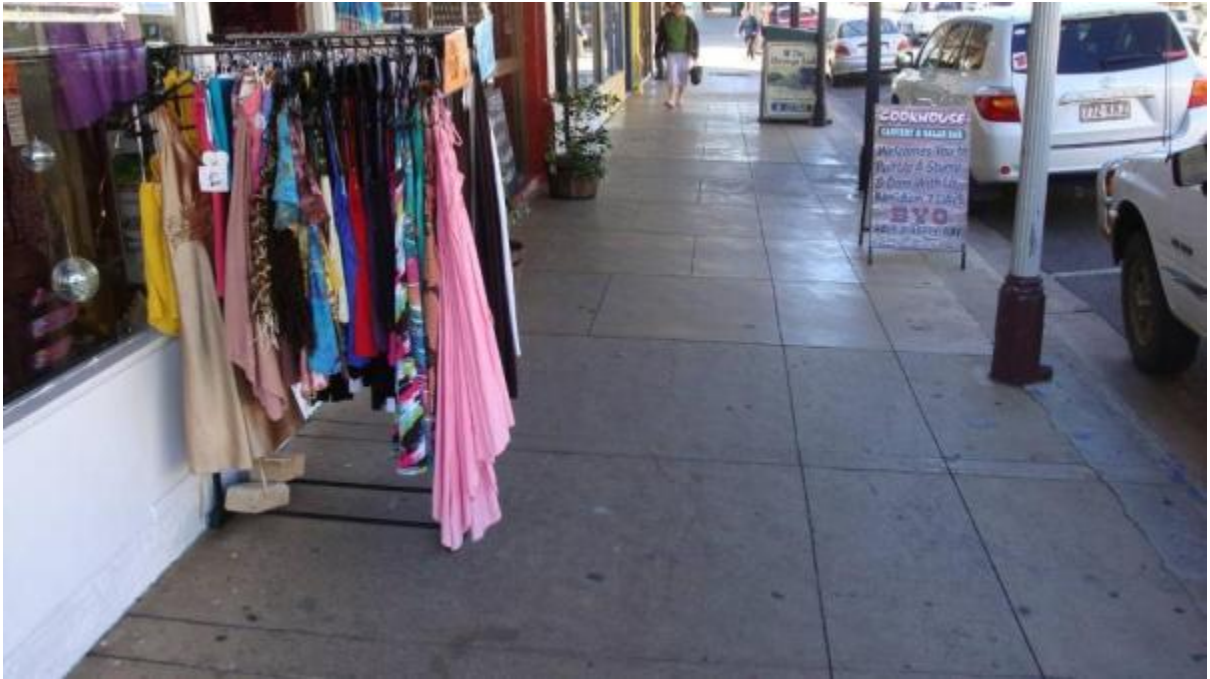
Photo 43

Location: dress shop and Cookhouse carvery.

The recommended clear unobstructed pavement width of a minimum of 1800mm is more appropriate to accommodate the typical use of the streets at peak times.

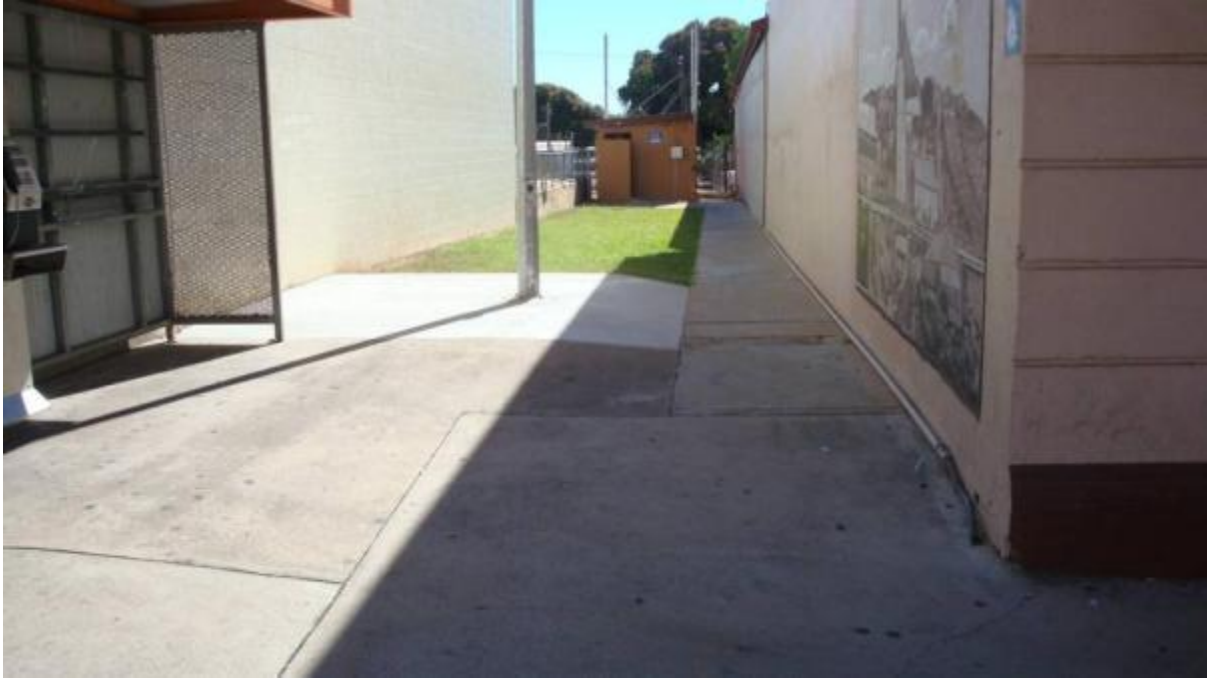
Photo 46

Public toilet between Outback Traders and Westpac, comprising men's and 1 x Accessible Uni-sex toilet.
