Access Report for Charters Towers

Charters Towers QLD 4816

**A report by:
John Mayo
Access Solutions
109 Logan Rd
Woolloongabba 4102
Phone: (07) 3391 2044
Fax: (07) 3391 2088**

Executive Summary

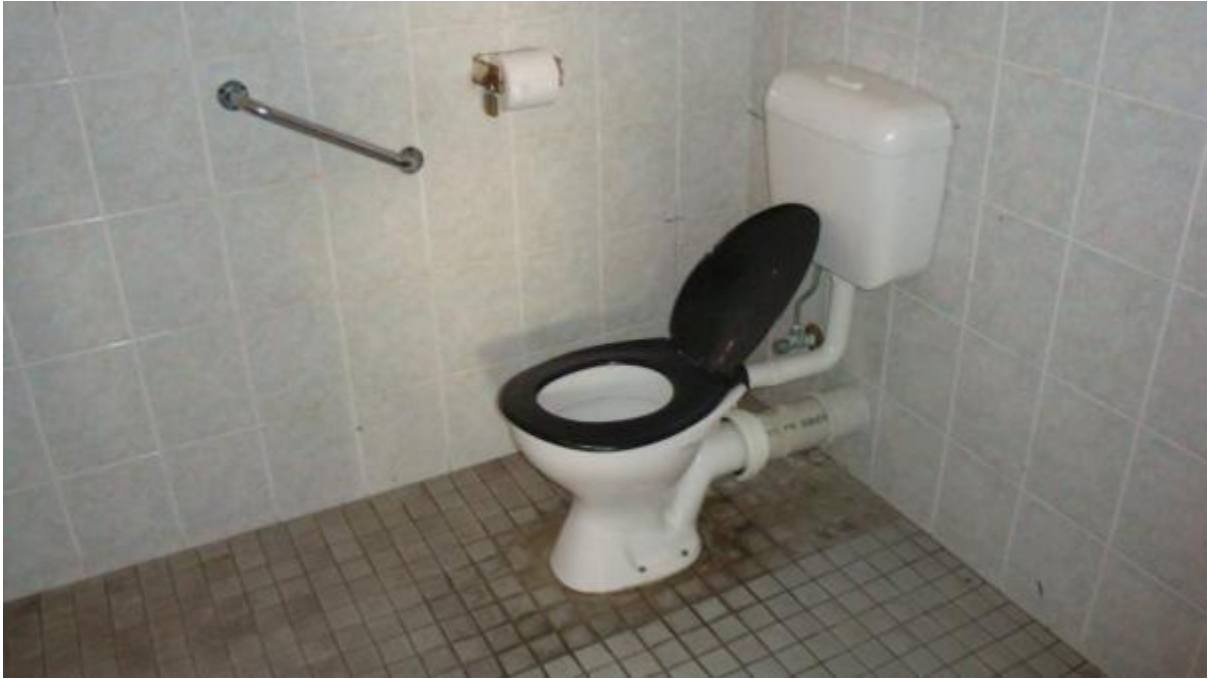
Photo 48

The existing Accessible Uni-sex toilet is spacious but location of toilet roll holder and existing grab rail are noncompliant. Refer to AS 1428.2 – 1992 and 'Accessible unisex toilets, showers, turning circle' document.

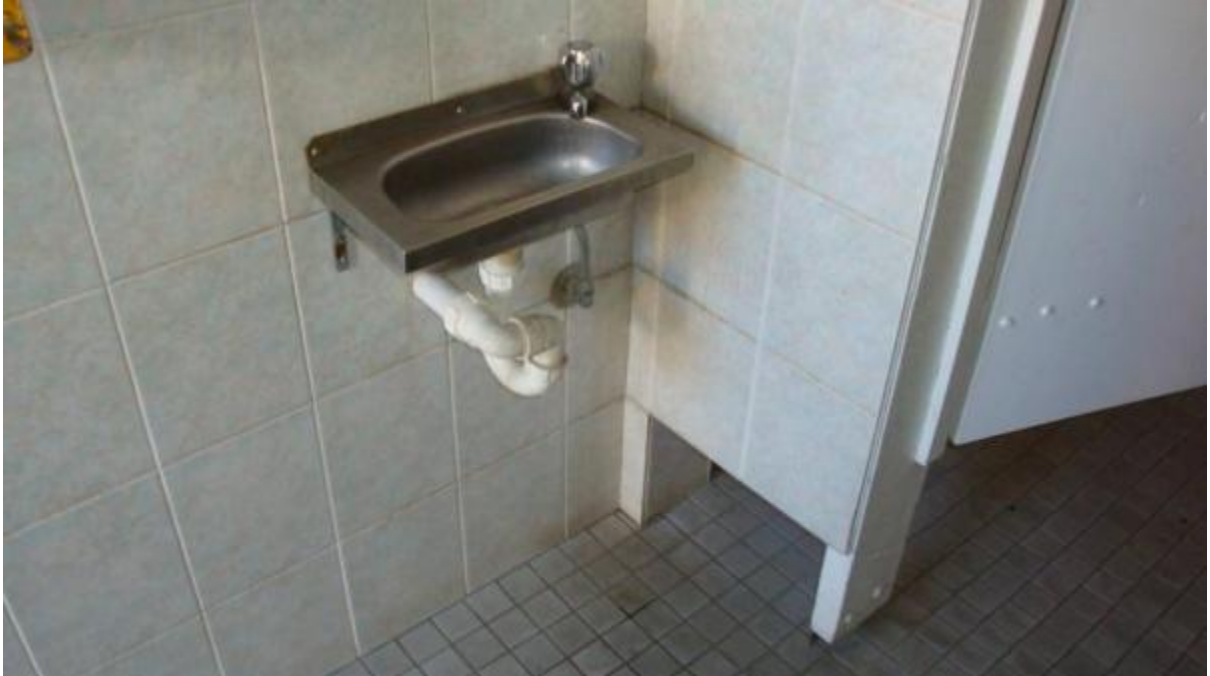
Photo 49

The hand basin is non-usable because it is in a corner next to a wall. People in wheelchairs cannot reach it.

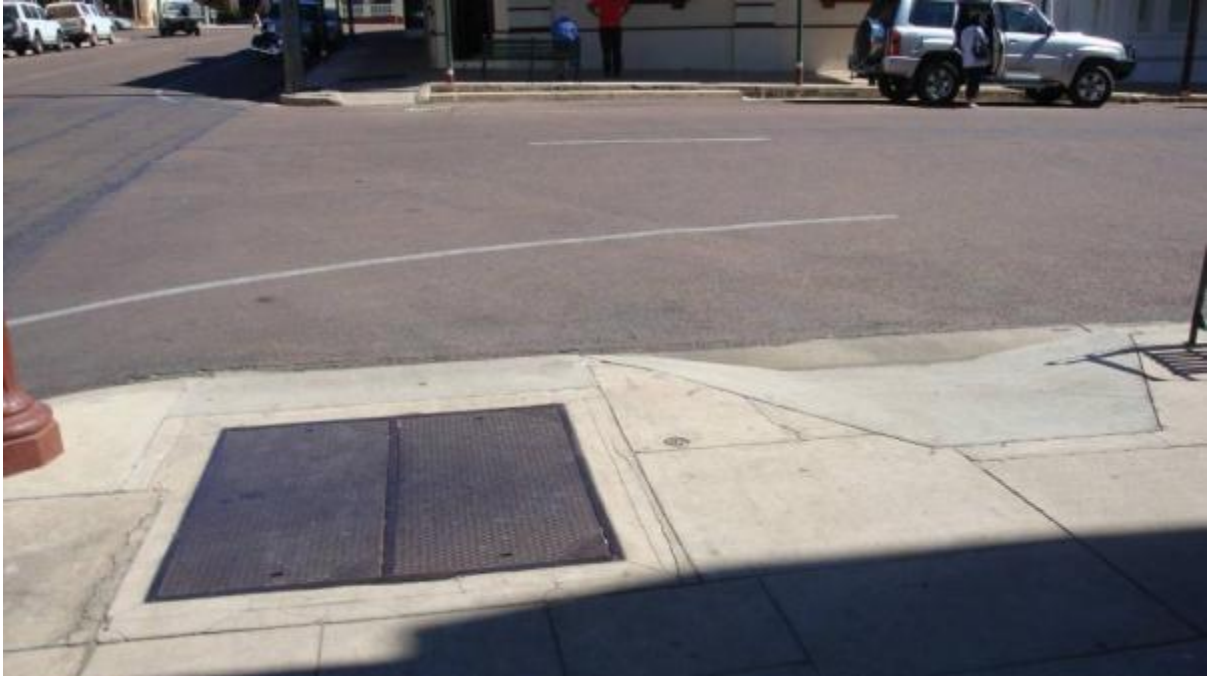
Photo 51

Pedestrian crossing at Gill Street north side intersecting with Bow Street.

It is recommended this become a 'zebra' crossing. The quandary is that it is not possible to align the Post Office side kerb ramp with the Travel Experience side kerb ramp in a straight line..

Engineering will have to note underground services as part of decision making. If a 'zebra' crossing is deemed acceptable, its line marking will have to dogleg or be angled to assist pedestrians to stay on its designated pathway.

The kerb ramps both sides of Bow Street require Hazard Tactile Ground Surface Indicators installed at the top of the kerb ramp to comply with AS1428.2 - 1992 Refer also to the referenced document 'Tactile Ground Surface Indicators and the Law'

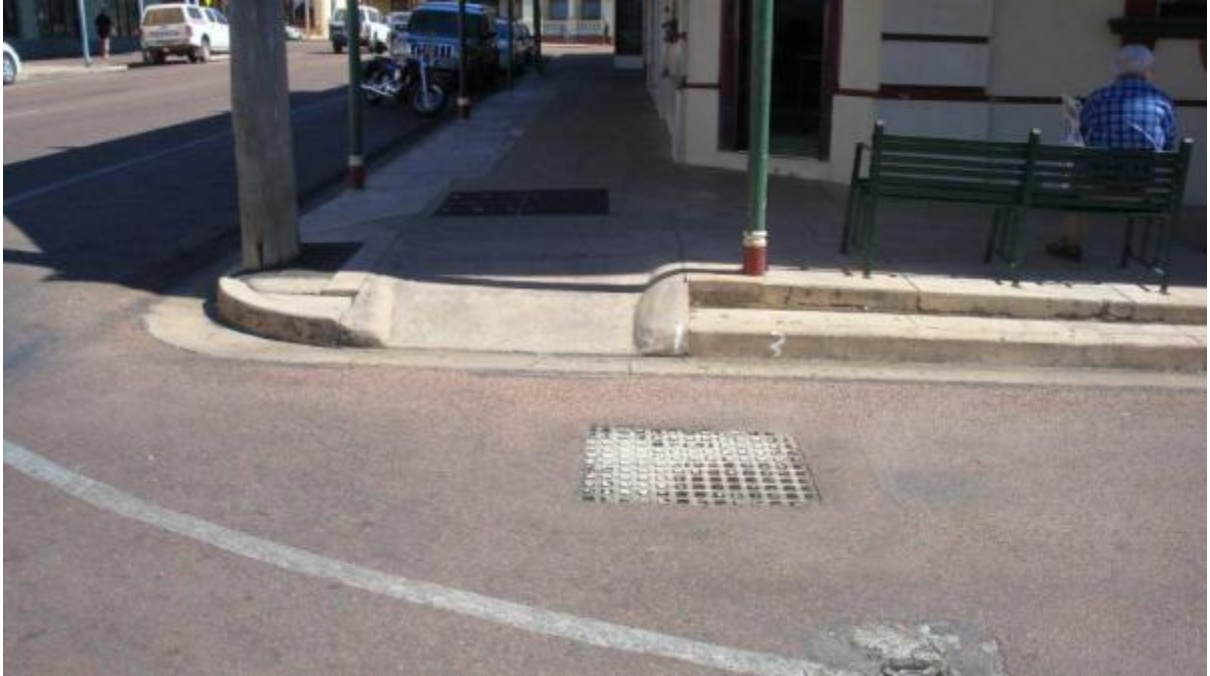
Photo 52

The kerb ramp at the Travel Experience side needs refurbishment to meet AS1428.2. It is too steep at present. Try to achieve a gradient for the kerb ramp of 1: 9 or gentler.

Install Hazard Tactile Ground Surface Indicators at the top of the kerb ramp to comply with AS1428.2 - 1992.

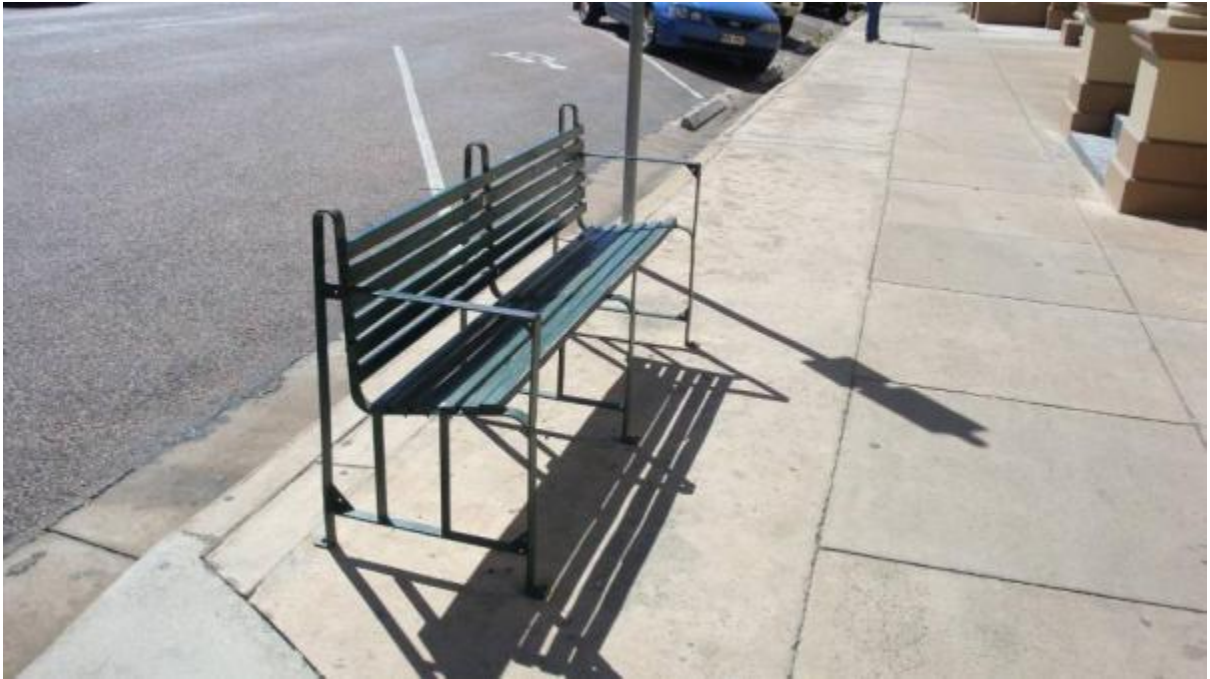
Photo 53

The older style seating with arm rests offer more assistance to aged users than modern seating without arm rests, an essential consideration to accommodate the needs of the aging population..

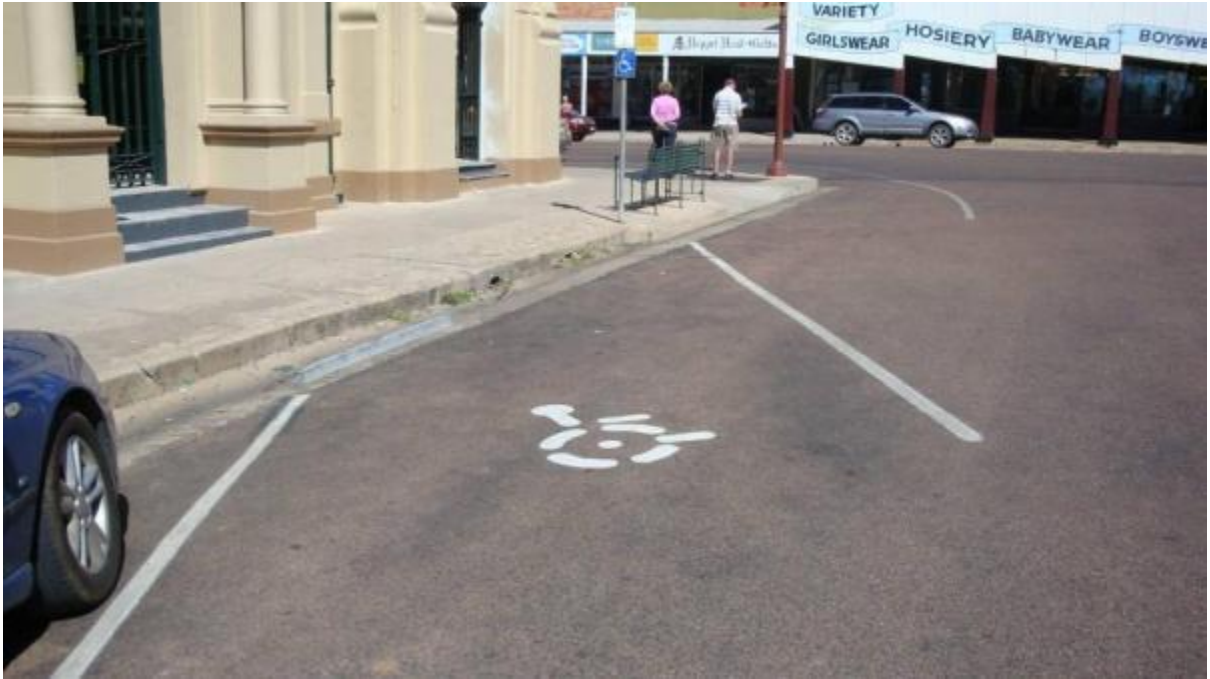
Photo 54

The disability parking bay outside the Post Office is a valued location. The crowning of the road and high kerbs are facts of life and should be generally accepted as such by majority of users.

Recommend extending the curved line marking for vehicles closer to the disability parking bay to give greater assurance and intuitiveness for wheelchair users who have to wheel on the road to connect from their vehicle to the kerb ramp.

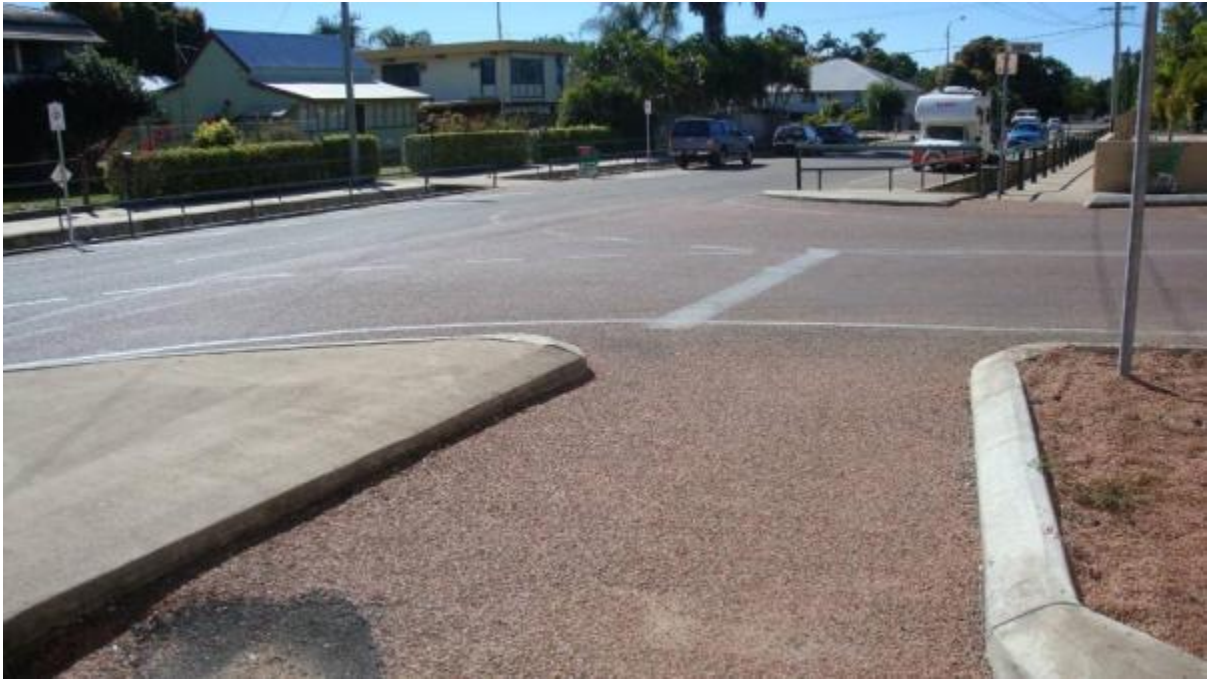
Photo 56

Audit trail: Deane Street east side.

Plan in the future to install vehicular access way Hazard Tactile Ground Surface Indicators at the two crossings where Deane and Ryan Streets intersect. Refer AS 1428.4 for compliance.

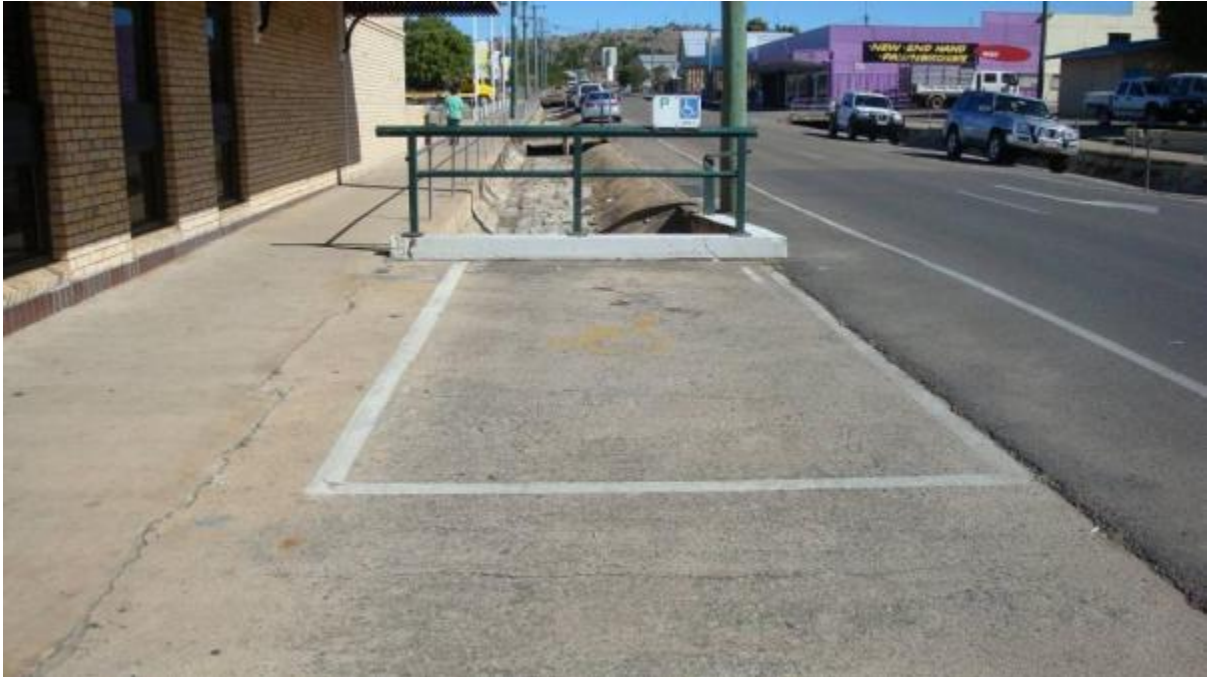
Photo 57

Disability bay well located. However, line marking must present as 3200mm between lines not the current 2700mm.

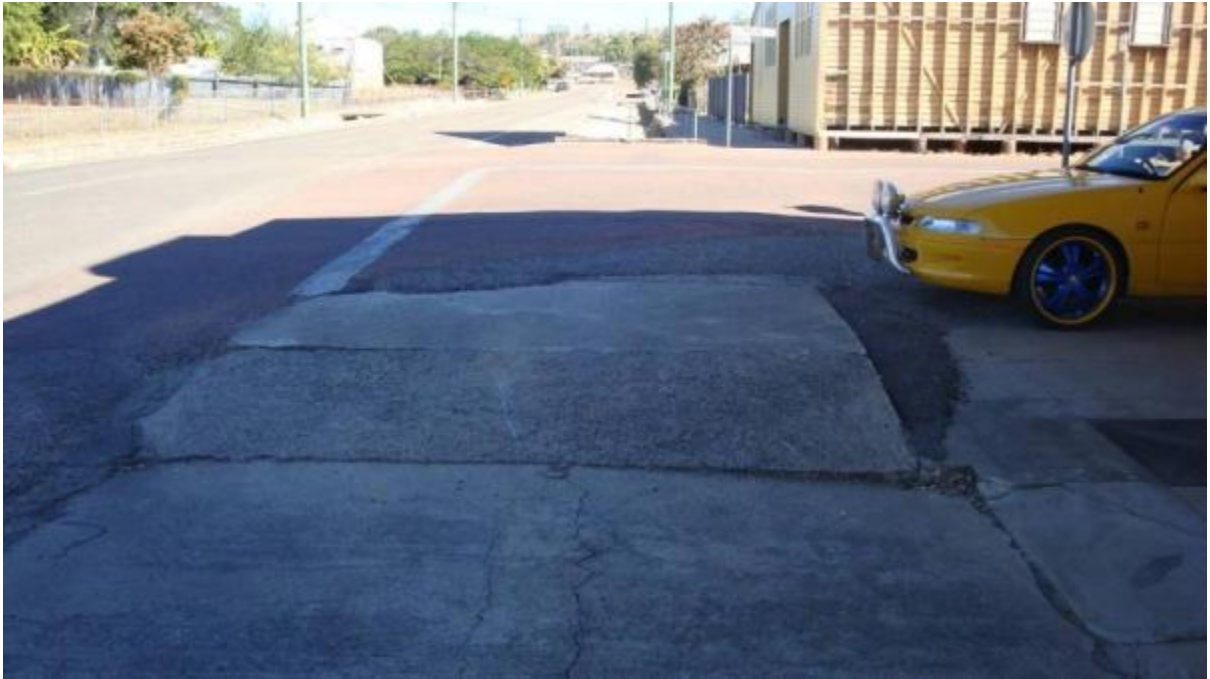
Photo 58

Audit trail: begins at corner of Jackson and Deane Streets.

Plan in the future to re-grade the crossing on the corner of Terry Fox Motors. It has a steep slope that is a potential risk.

Driveway Hazard Tactile Ground Surface Indicators required at Terry Fox Motors, then at furniture storage shed, then at Powell Lane. Comply with AS 1428.4

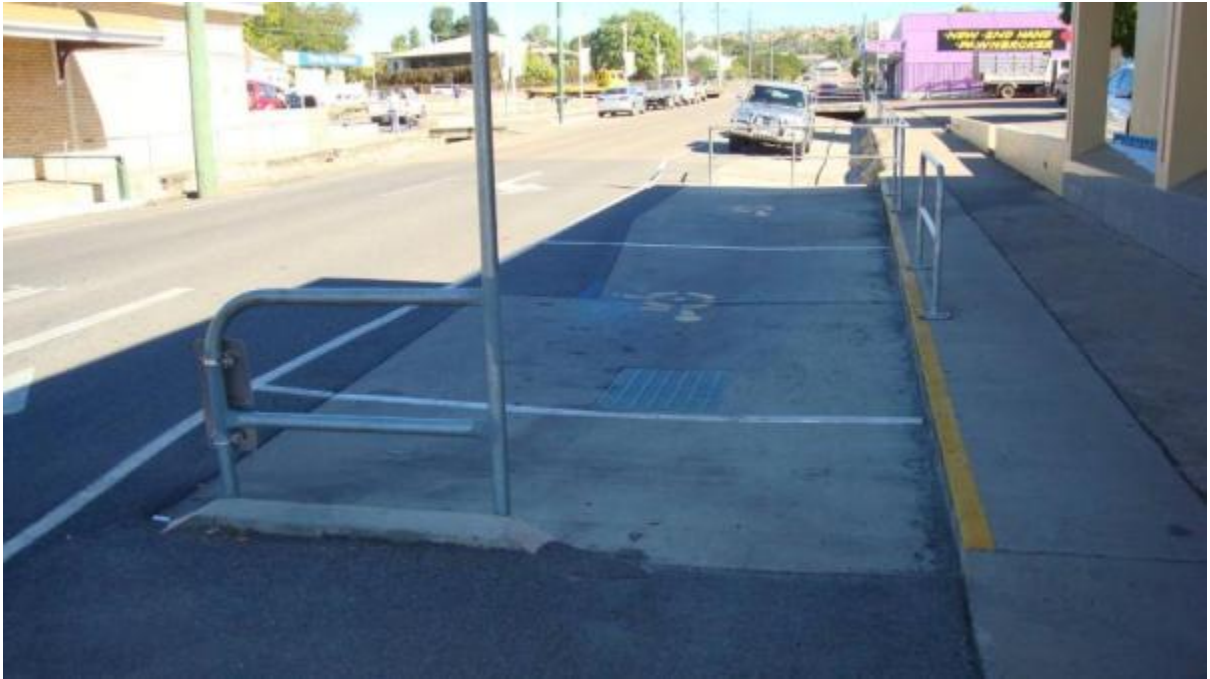
Photo 59

2 x disability bays are in handy location.

Replace kerb adjacent carparking bay with a lipless driveway detail to allow immediate safe access to the footpath. Refer 'Lipless driveway technical drawing' document.

Install Hazard Tactile Ground Surface Indicators at the top of the kerb ramp to comply with AS1428.2 - 1992.

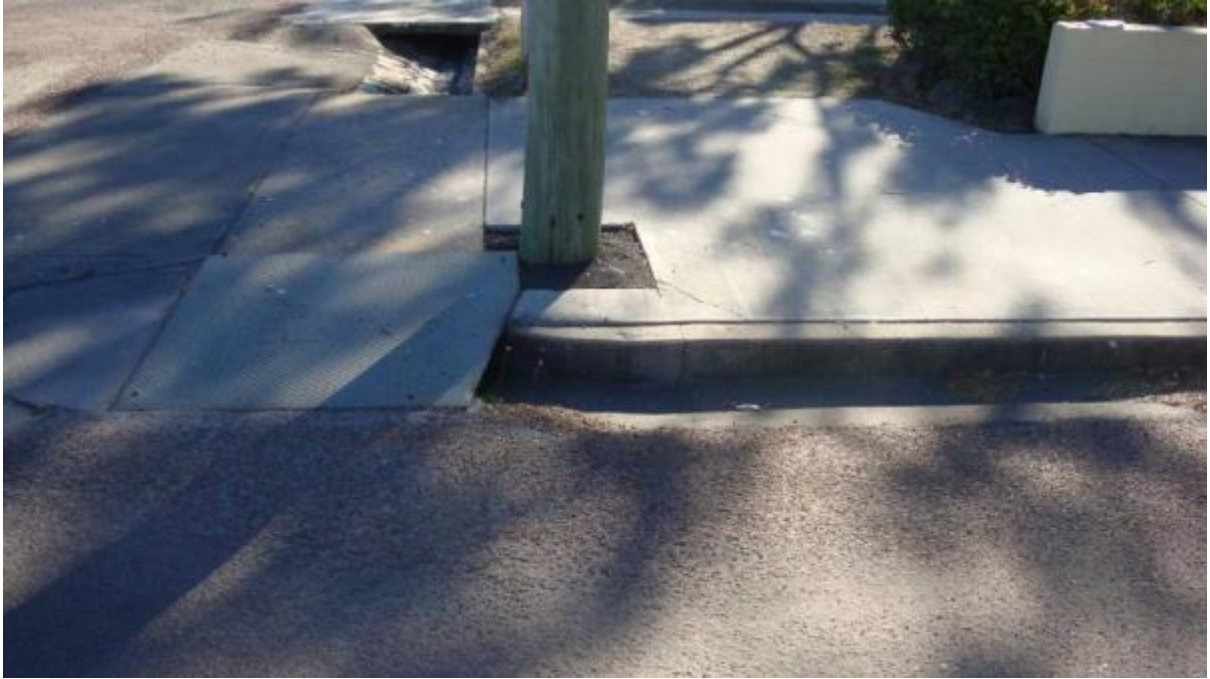
Photo 63

If a person with vision impairment or mobility device or crutches uses the existing checker plate and falls in the drain, Council will be potentially liable.

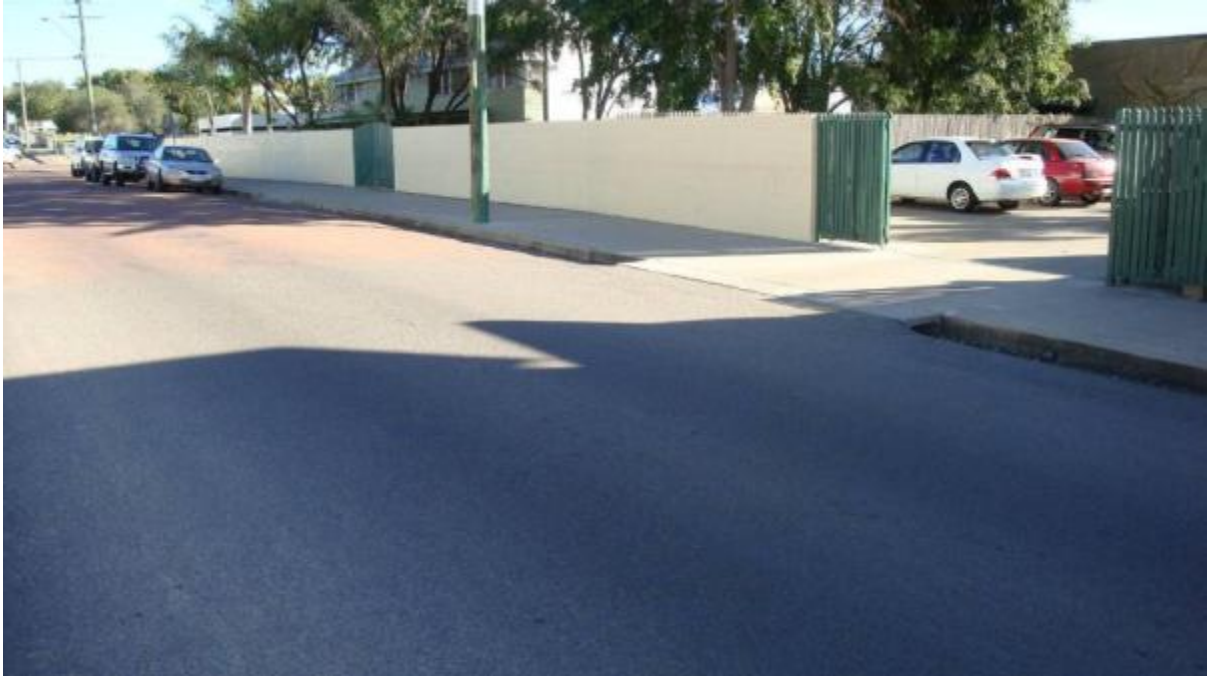
Photo 64

4.
Provision more disability parking. Some locations are specified. In particular, see Library precinct (Photo 64) and June Black Hall precinct (photo 89).
The consultant is working with the local access group and may recommend further locations.

Disability parking essential near Library but road is heavily crowned and narrow near Gill Street.

Recommendation: Install an on street disability bay between the gated library staff park and the gated building south of the library car park. Mobility device users can have access to either gated driveway (although library driveway has the smoothest transition) to access library in Gill Street.

Driveway Hazard Tactile Ground Surface Indicators required at library staff car park to comply with AS 1428.4

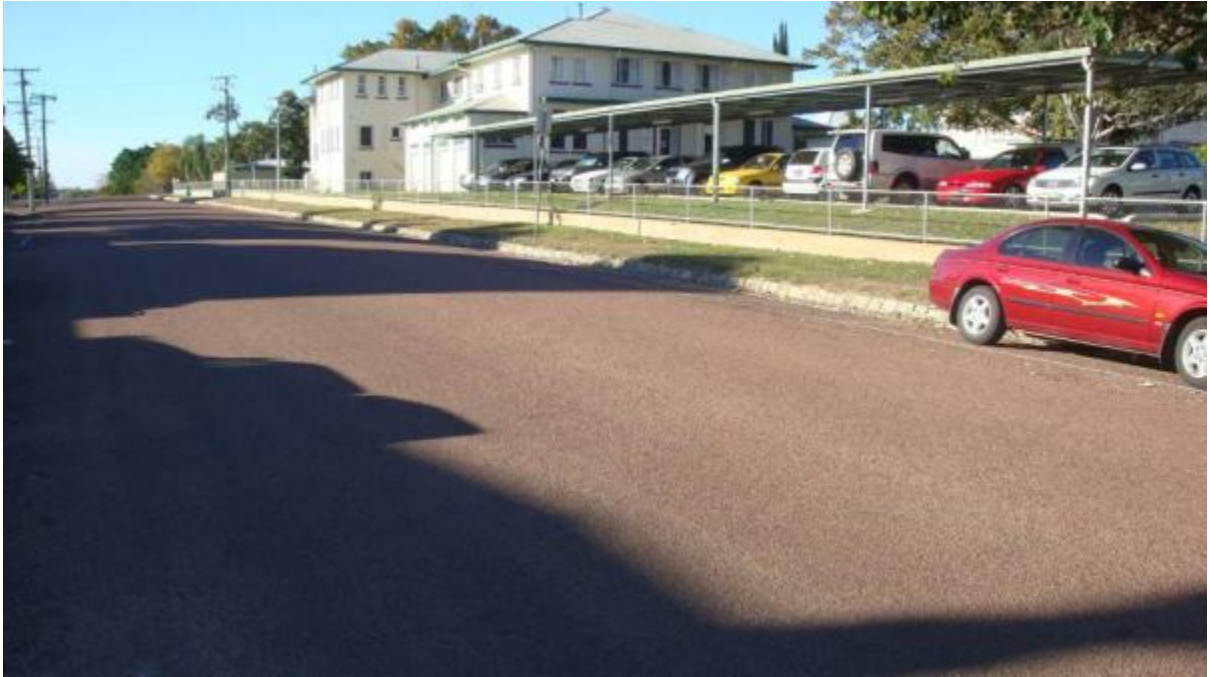
Photo 65

Audit trail: High Street east side from Gill Street.

There is no footpath on the east side and as Queensland Health has fenced its site and there are no access points to its site, there is currently little point in planning for a footpath. But in that event, a footpath on the west side of High Street should be available.

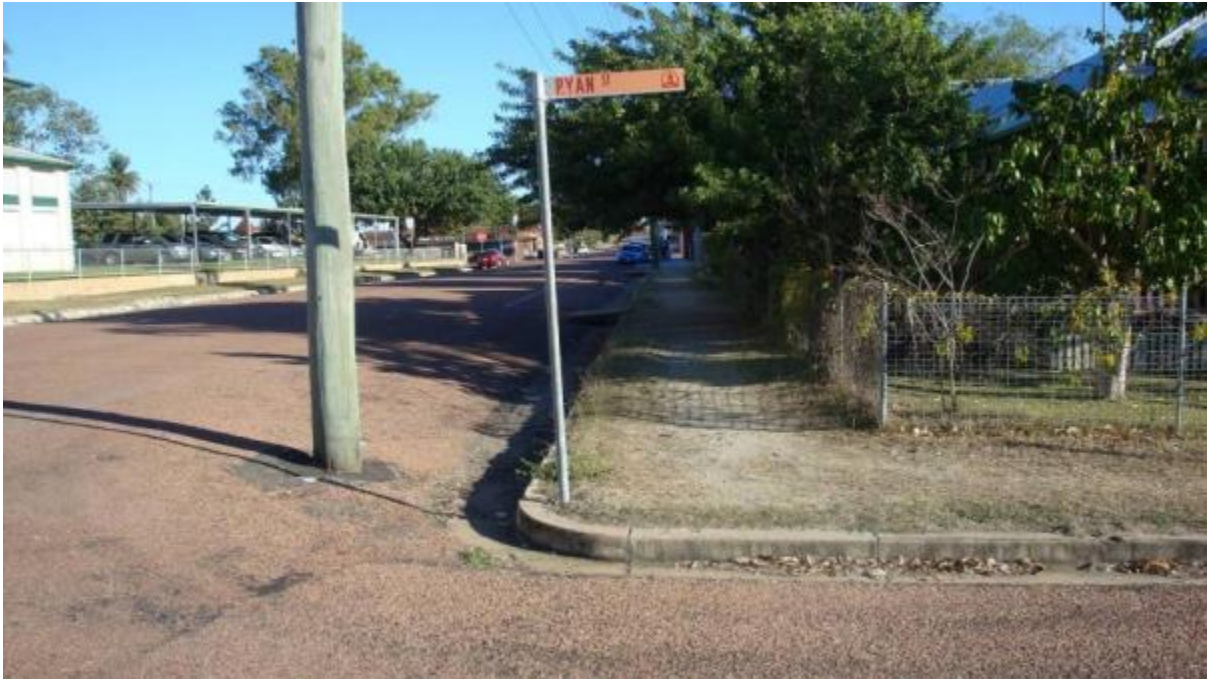
Photo 66

Audit trail: High Street west side.

Note: Council is being very charitable in allowing such a large Vinnies bin to occupy footpath space.

Recommendation: Install kerb ramp at Ryan Street south west corner.

For future, plan brushed concrete footpath to connect to Gill Street. The minimum width of an accessible path of travel described in AS 1428.2 – 1992 is 1200mm. However in many situations a greater width is recommended to accommodate peak use.

Driveway Hazard Tactile Ground Surface Indicators required at Vinnies. Comply with AS 1428.4 and refer to 'Tactile Ground Surface indicators and the law'

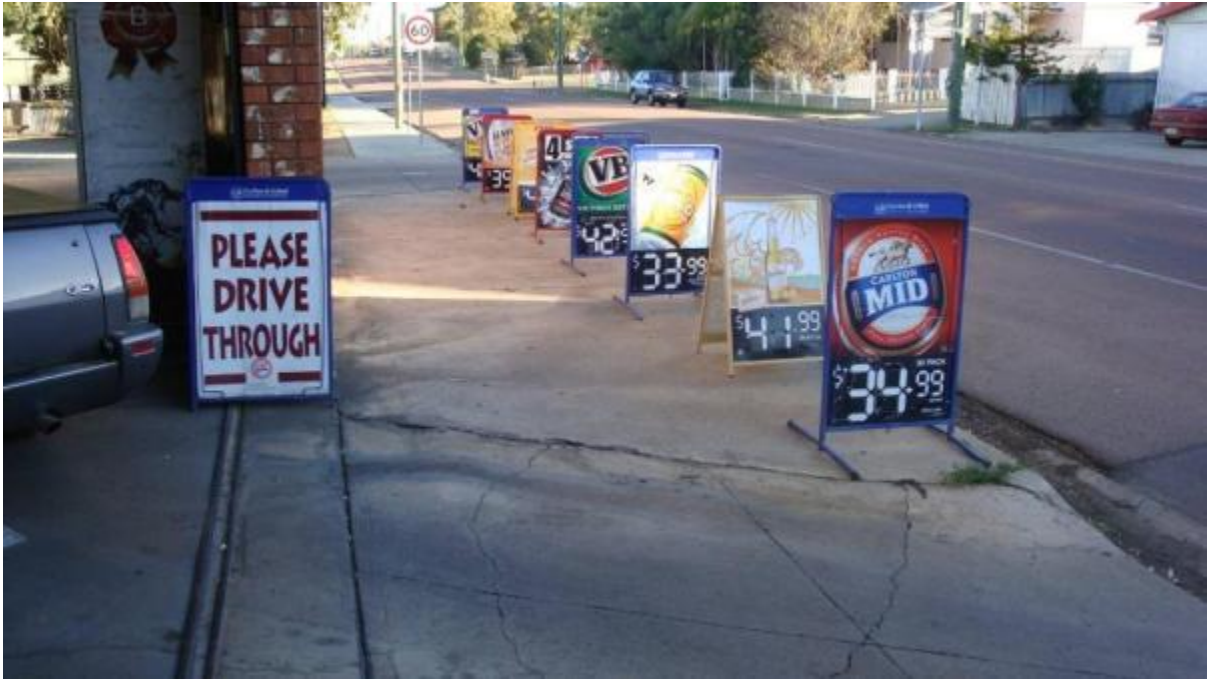
Photo 67

Audit trail: High Street east side heading south from Gill Street.

Hotel signage is hazardous to pedestrians and unsightly, there are 10 billboards to avoid.

The consultant was advised that some parents had approached hotel management about the hazard to school children who use this footpath daily and were told it was “None of their damned business”.

The recommended clear unobstructed pavement width of a minimum of 1800mm allows comfortable passing or side-by-side travel for 2 wheelchairs or prams and completion of a 180 degree turn in a mobility device. Refer AS 1428.2-1992 cl.6.5.

Ensure that other hazards, such as seating, bins, signage, bollards or other barriers do not impede a clear circulation space of 1800mm minimum clear width.

Driveway Hazard Tactile Ground Surface Indicators are required at Tavern Drive through – entry and exit in accordance with AS 1428.4

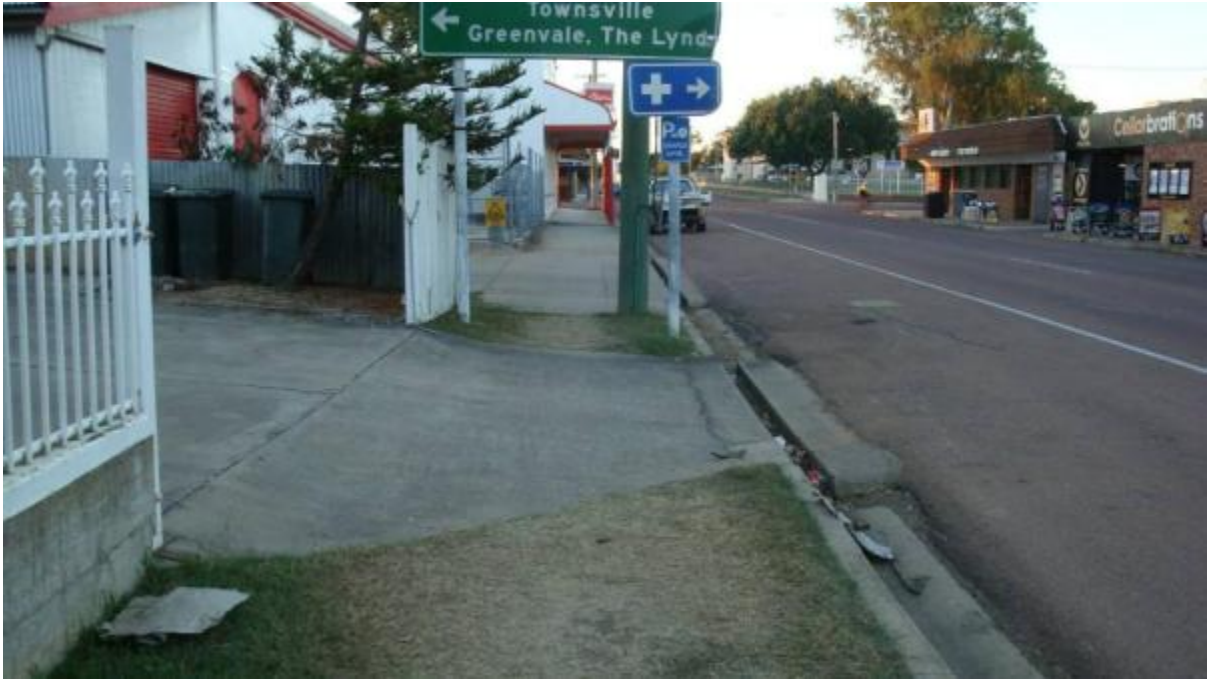
Photo 72

Audit trail: High Street west side from Mexican Street to Gill Street.

There is little point in recommending anything until Council has the funds to install a brushed concrete footpath from Mexican Street to Gill Street.

There are some businesses with driveways on this side of High Street but Hazard Tactile Ground Surface Indicators will not be required until a footpath is laid. People with vision impairment can detect when a grass surface changes to a concrete surface.

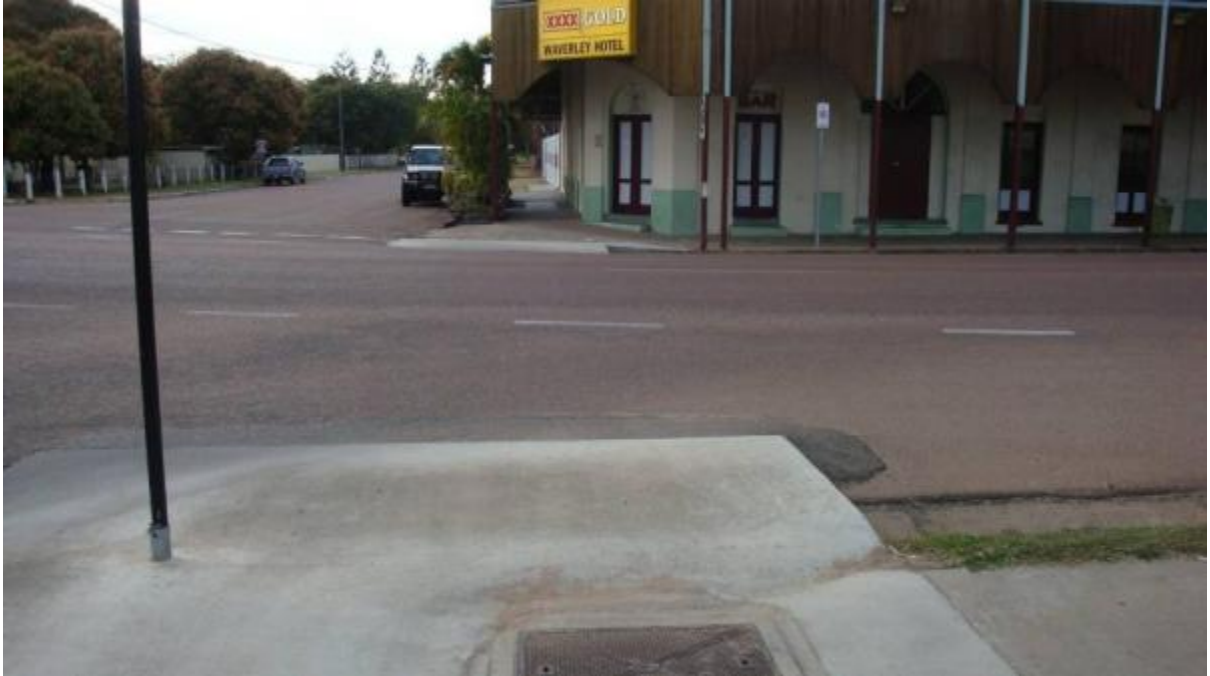
Photo 73

Audit trail: Mosman Street west side from Jane to Jackson Street.

Pedestrian crossing at Jane Street and Mosman Street requires Hazard Tactile Ground Surface Indicators, both sides of Mosman Street. Refer to the referenced document 'Tactile Ground Surface Indicators and the Law'

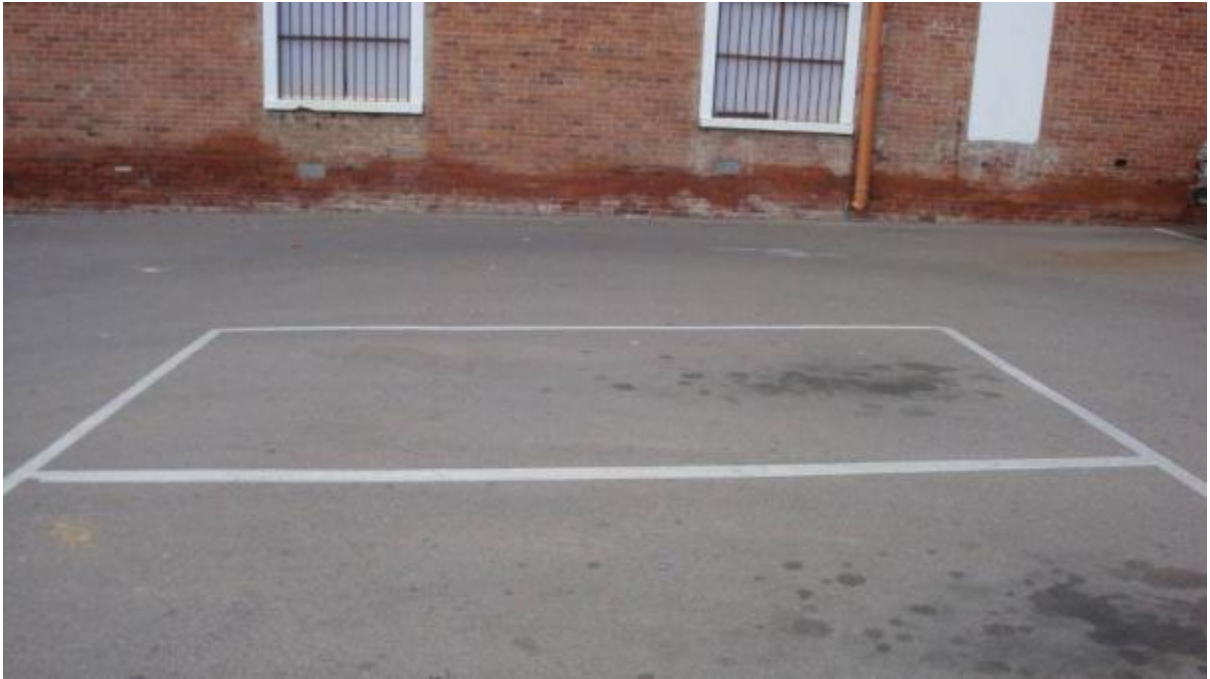
Photo 89

At Council's car park opposite the June Black Hall there should be at least one disability bay. The issue is the crossfall. There are almost no bays that would meet 1: 40.

Council car park 2 x driveways require Hazard Tactile Ground Surface Indicators. Also at Rix Hotel car park.

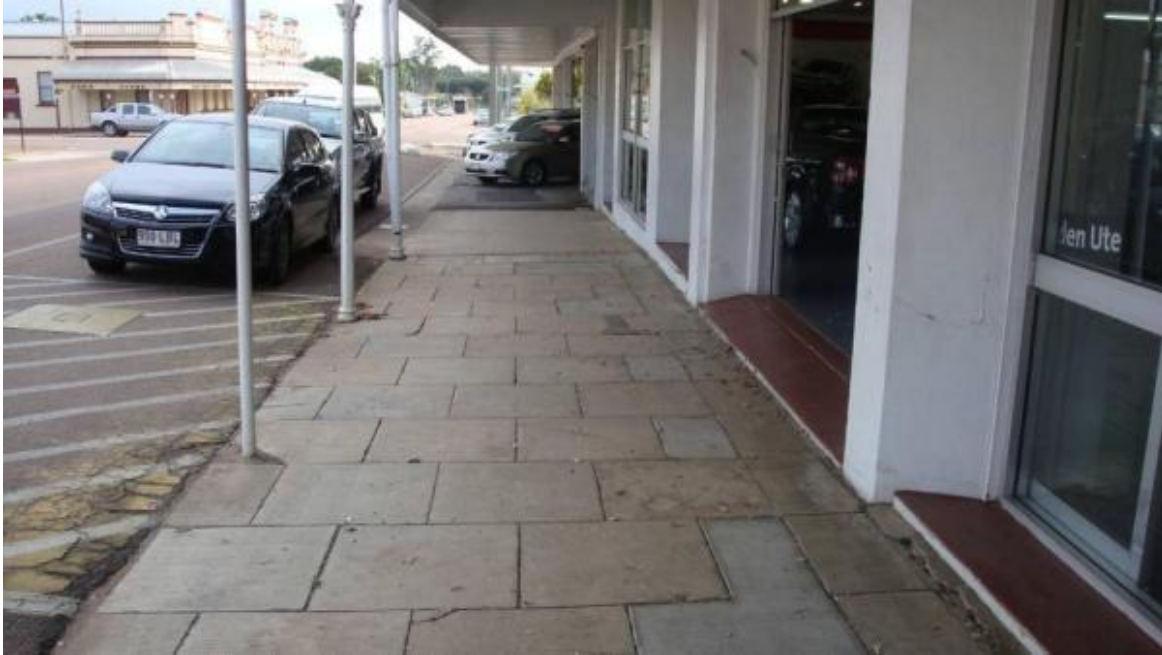
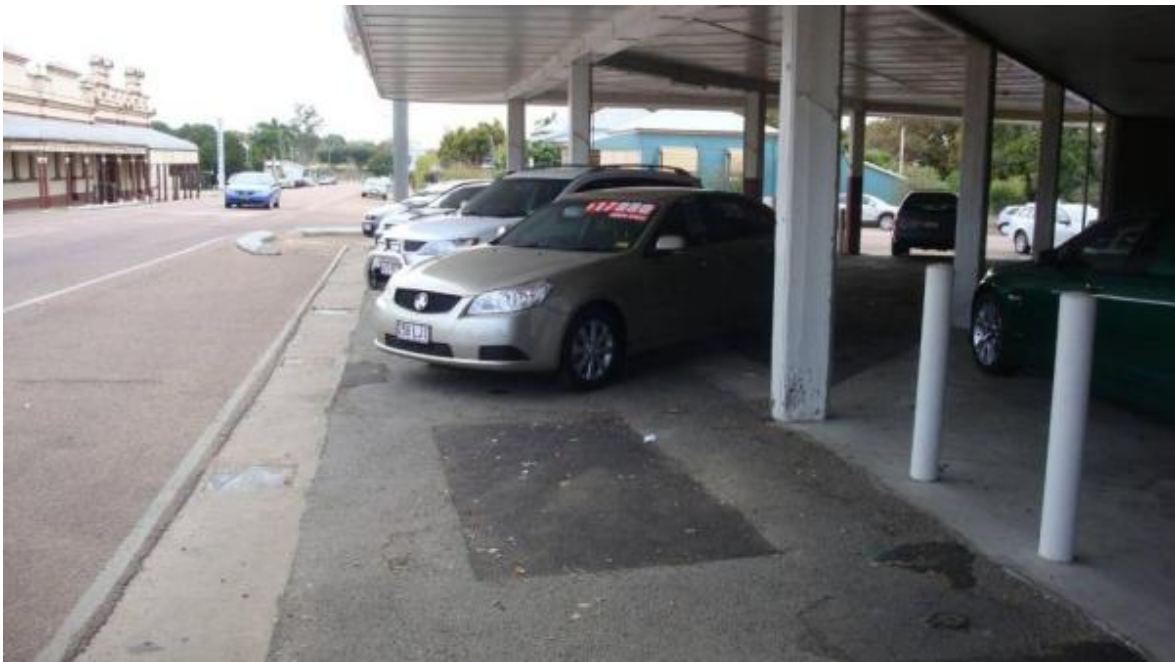
Photos 90 and 91

Where the footpath nears Tony Ireland Motors, a curiosity occurs. Showroom vehicles protrude into the pedestrian's path of travel.

Regardless of the ultimate outcome about the path of travel, a compliant pedestrian crossing with Hazard Tactile Ground Surface Indicators is required to link Mosman Street at Mary Street. Refer to the referenced document 'Tactile Ground Surface Indicators and the Law'

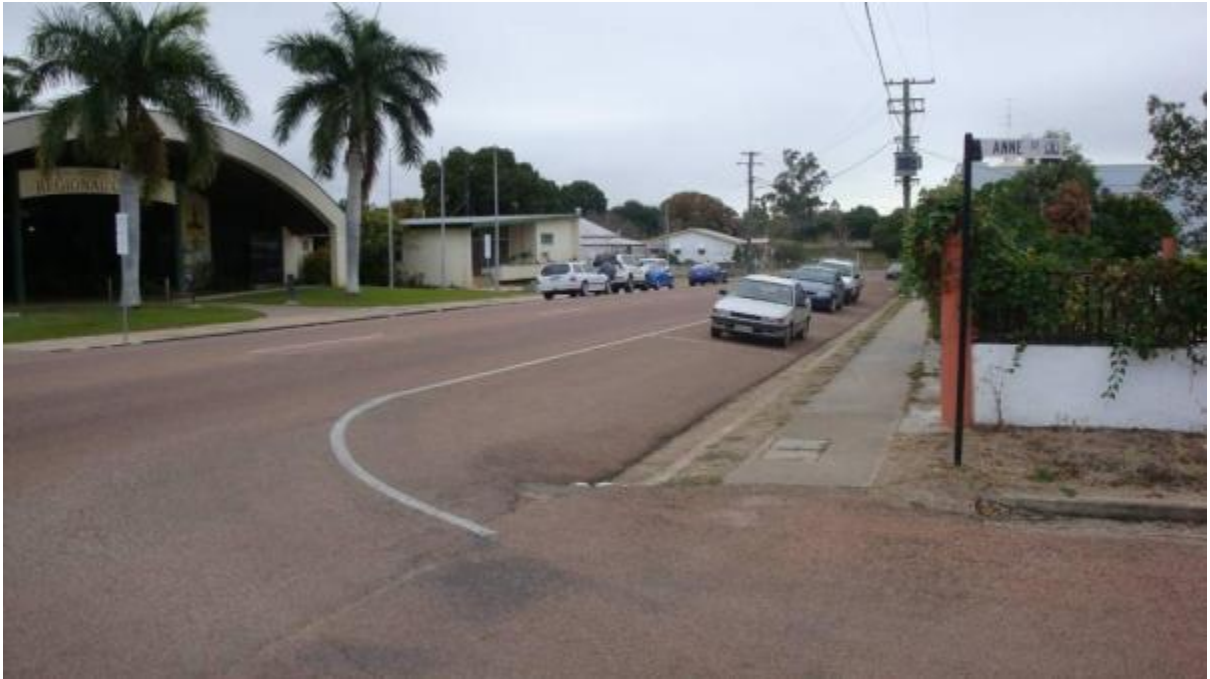
Photo 95

Although there are residences in this part of Mosman Street, there is the Council Office and various businesses to link into by pedestrians and it is these service providers who will attract pedestrians to the precinct and hence the judgment to specify Hazard Tactile Ground Surface Indicators in this stretch of Streetscape.

The opposite side of the street footpath pedestrian connection simply requires Hazard Tactile Ground Surface Indicators. In accordance with AS1428.4. Refer also to the referenced document 'Tactile Ground Surface Indicators and the Law'
